Asbestos and Hazardous Materials Reinspection Assessment

Milson Island Sport & Recreation Centre

Report Date: 25/01/2023

754-SYDEN311850 - Milson Island Sport and Recreation Centre - HMRR - 16012023

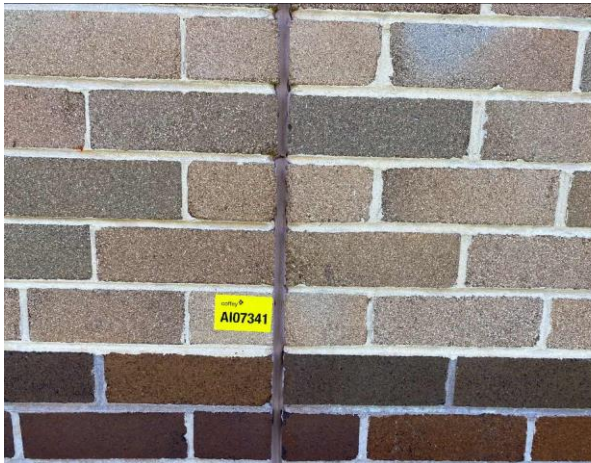
Line ID 1: External, Accommodation Lodges, Lorikeet, Kookaburra, Waratah, Koala and Possum, Throughout, Joint Mastic Between Bricks, Construction Joint Mastic - No Asbestos Detected

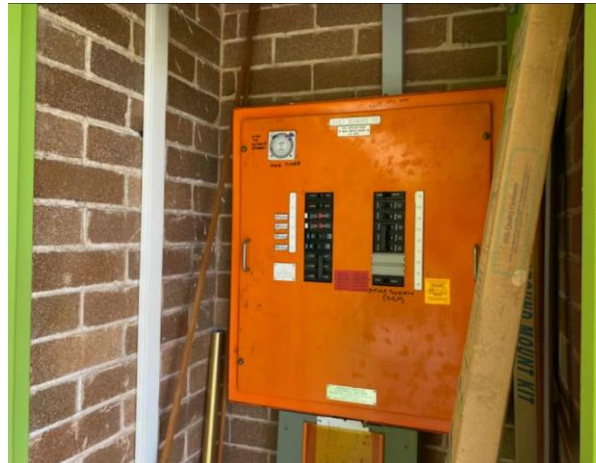
Line ID 2: External, Accommodation Lodges, Lorikeet, Kookaburra, Waratah, Koala and Possum, Wall Mounted Electrical Cupboards, HRC Fuses - Suspected Asbestos

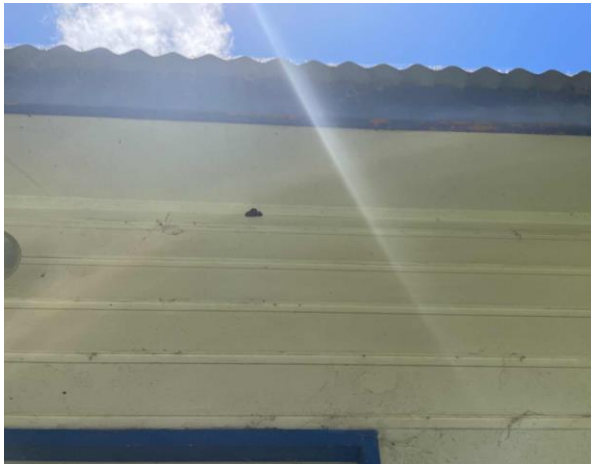
Line ID 3: External, Boat Maintenance Shed, Ground Floor, Eaves, Fibre Cement Sheeting - Suspected Asbestos

External	Boat Maintenance Shed / Ground Floor / Eaves	Fibre Cement Sheeting	Asbestos	754-SYDEN311850 230A13	Suspected Asbestos	Non-Friable	20 m²	Low	5 Yearly Reinspection	Not sampled due to height restrictions. Confirm status and maintain in current condition if to remain in-situ. Remove under controlled non-friable asbestos removal conditions prior to refurbishment or demolition works by a Class B (non-friable) licensed asbestos removal contractor in accordance with relevant State Regulations, Compliance Codes, Codes of Practice and Guidance Notes.	3
External	Dining Room / Throughout / East Side Dining Area, Poles to Ground	Mastic Sealant	Asbestos	AI07355	No Asbestos Detected	-	1 Unit	-	-	-	4

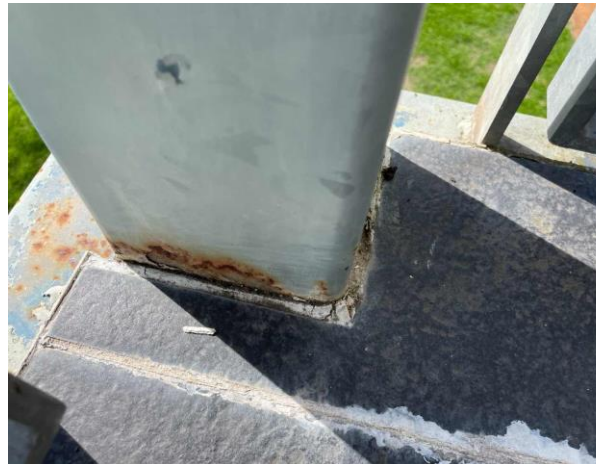
Line ID 4: External, Dining Room, Throughout, East Side Dining Area, Poles to Ground, Mastic Sealant - No Asbestos Detected

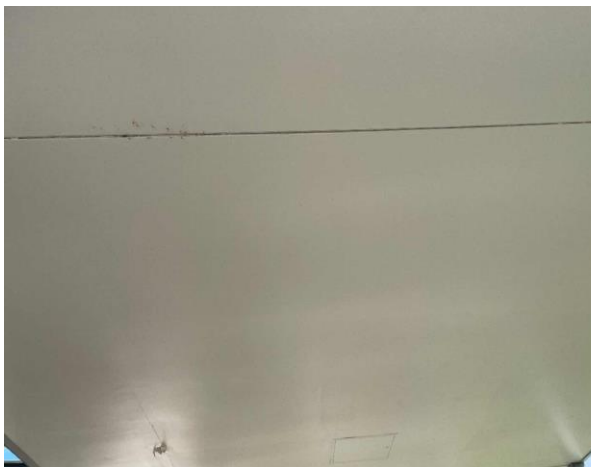
Line ID 5: External, Dining Room, Throughout, East Side Dining Area, Underside of Canopy, Compressed Cement Sheeting - Suspected Asbestos

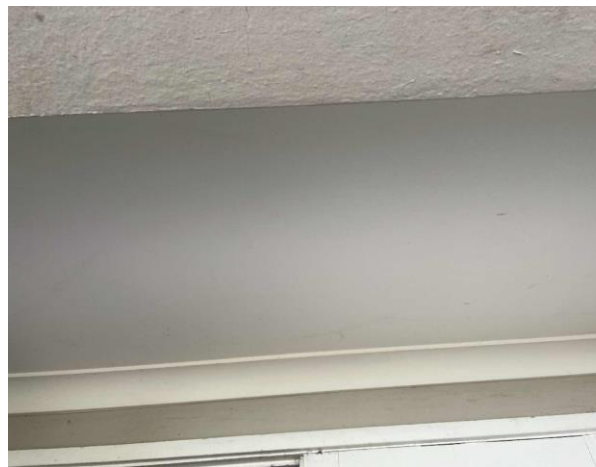
Line ID 6: External, Dining Room, Throughout, West Entrance Awning, Plaster Board - No Asbestos Suspected

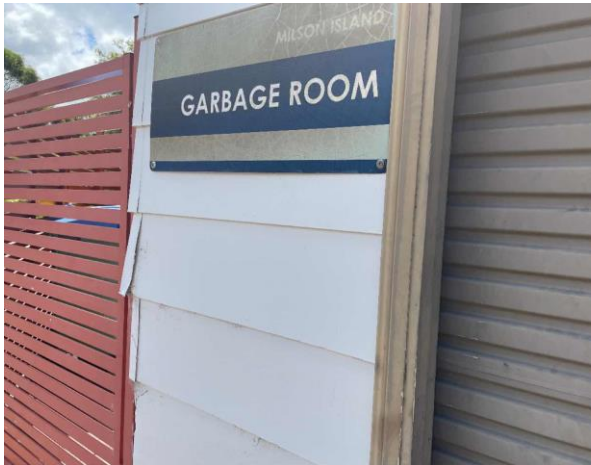
Line ID 7: External, Garbage and Fire Pump Rooms, Ground Floor, Garbage Room, Wall Lining, Fibre Cement Sheetting - No Asbestos Detected

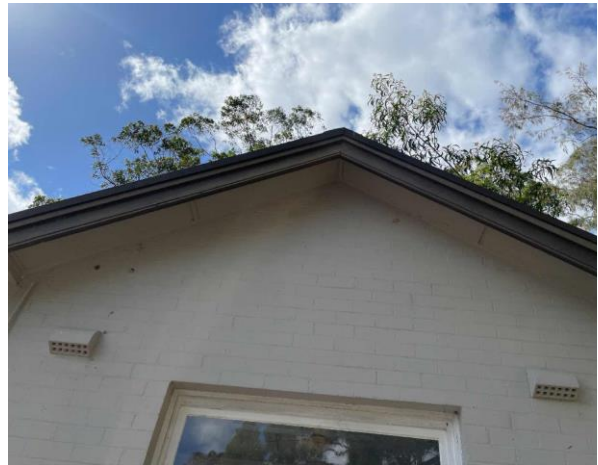
Line ID 8: External, Laundry, Ground Floor, Throughout Building, Eaves, Fibre Cement Sheetting - Suspected Asbestos

External	Laundry / Ground Floor / Throughout Building, Eaves	Fibre Cement Sheeting	Asbestos	754-SYDEN311850 230A7	Suspected Asbestos	Non-Friable	30 m²	Low	5 Yearly Reinspection	Not sampled due to height restrictions. Confirm status and maintain in current condition if to remain in-situ. Remove under controlled non-friable asbestos removal conditions prior to refurbishment or demolition works by a Class B (non-friable) licensed asbestos removal contractor in accordance with relevant State Regulations, Compliance Codes, Codes of Practice and Guidance Notes.	8
External	Maintenance Shed / Ground Floor / Eaves to Shed and Debris From Damaged Eaves	Fibre Cement Sheeting	Asbestos	AI07340	No Asbestos Detected	-	30 m²	-	-	-	9

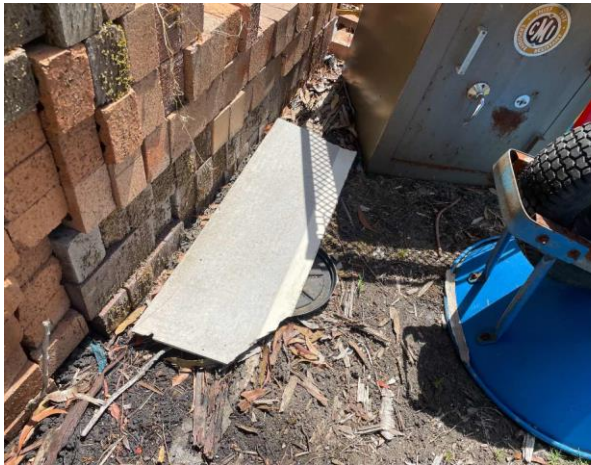
Line ID 9: External, Maintenance Shed, Ground Floor, Eaves to Shed and Debris From Damaged Eaves, Fibre Cement Sheetting - No Asbestos Detected

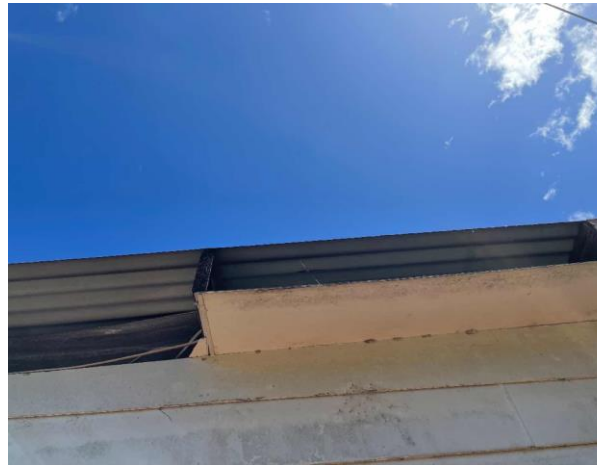
Line ID 9.1: External, Maintenance Shed, Ground Floor, Eaves to Shed and Debris From Damaged Eaves, Fibre Cement Sheetting - No Asbestos Detected

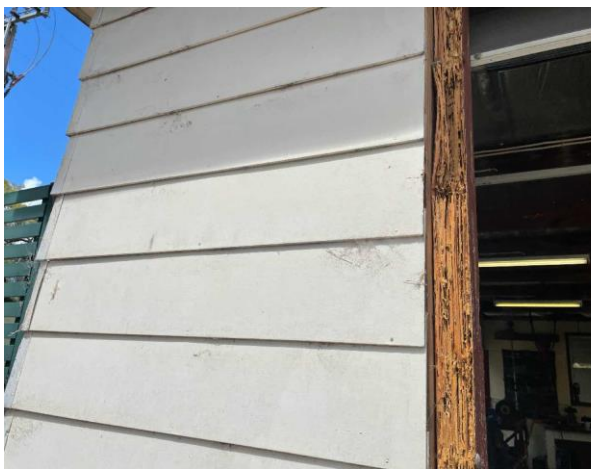
Line ID 11: External, Maintenance Shed, Ground Floor, Walls, Weatherboard Cladding, Fibre Cement Sheetting - No Asbestos Detected

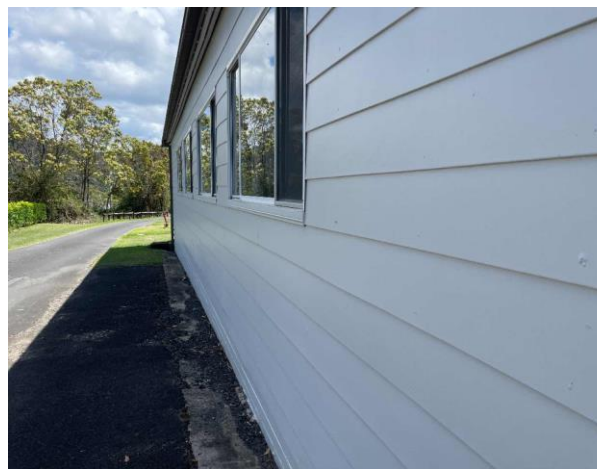
Line ID 12: External, Platypus Lodge, Ground Floor, Walls, Weatherboard Cladding, Fibre Cement Sheetting - No Asbestos Detected

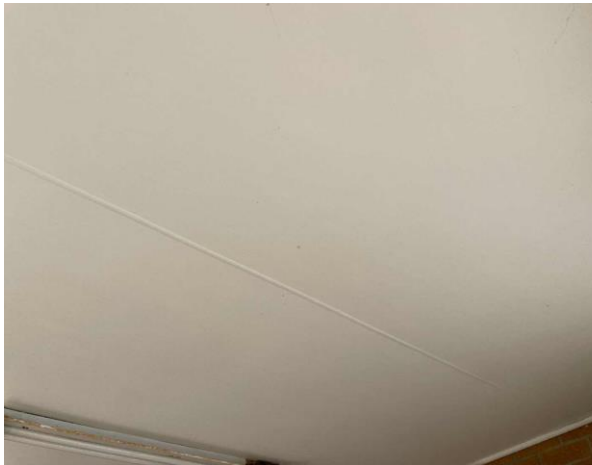
Line ID 13: External, Pool Area, Ground Floor, Ceiling Lining Adjacent Entrance to Pool Pump Room, Compressed Cement Sheeting - No Asbestos Detected

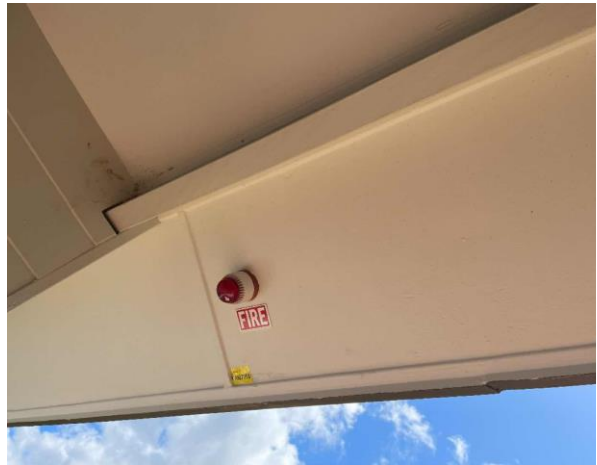
Line ID 14: External, Reception, Ground Floor, Eaves, Fibre Cement Sheeting - Chrysotile, Amosite and Crocidolite Asbestos Detected

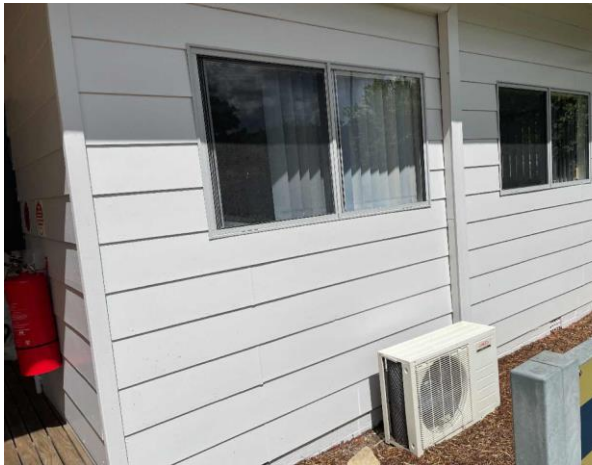
Line ID 15: External, Reception, Ground Floor, Walls, Weatherboard Cladding, Fibre Cement Sheeting - No Asbestos Detected

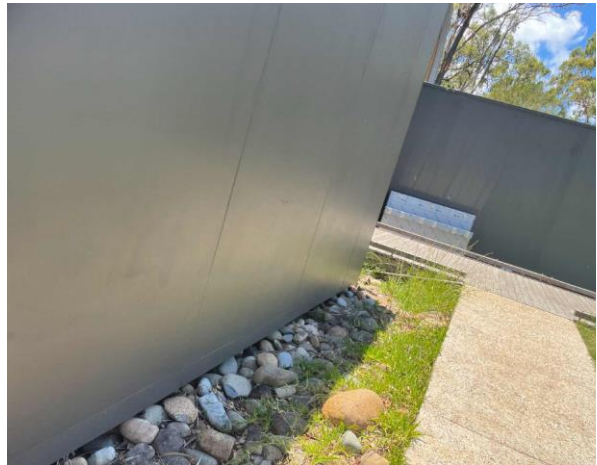
Line ID 16: External, Recreation Hall, Ground Floor, Wall Lining, Compressed Cement Sheet - No Asbestos Detected

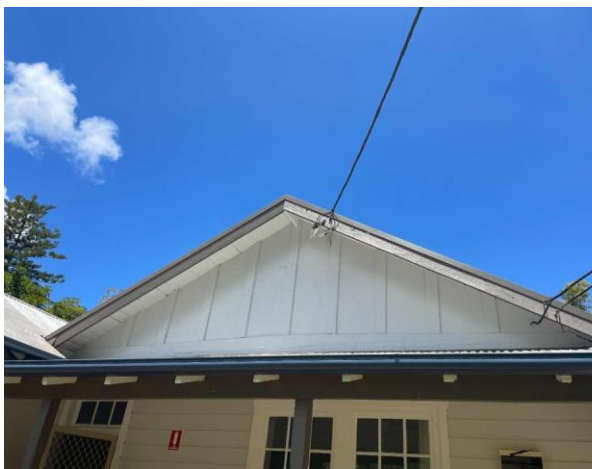
Line ID 17: External, Staff Residence, Ground Floor, Fascia Panels to Gable, Fibre Cement Sheeting - Suspected Asbestos

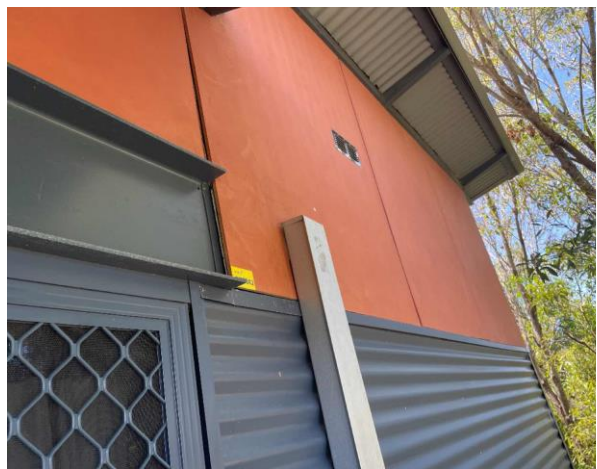
Line ID 18: External, Units 1-5, Ground Floor, Upper Wall Lining, Compressed Cement Sheet - No Asbestos Detected

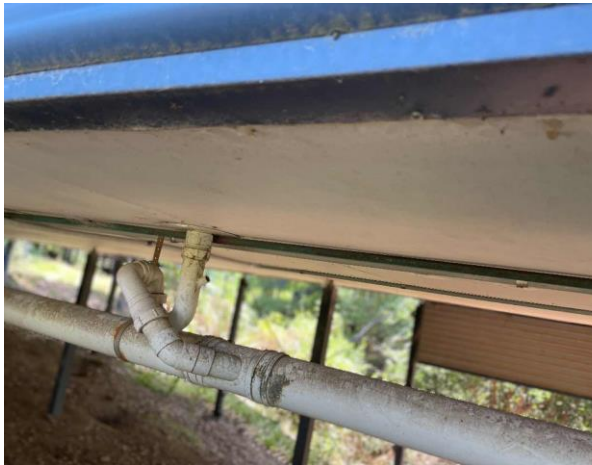
Line ID 19: External, Units 1-5, Ground Floor, Waterproofing Membrane to Underside of Unit, Fibre Cement Sheetting - No Asbestos Detected

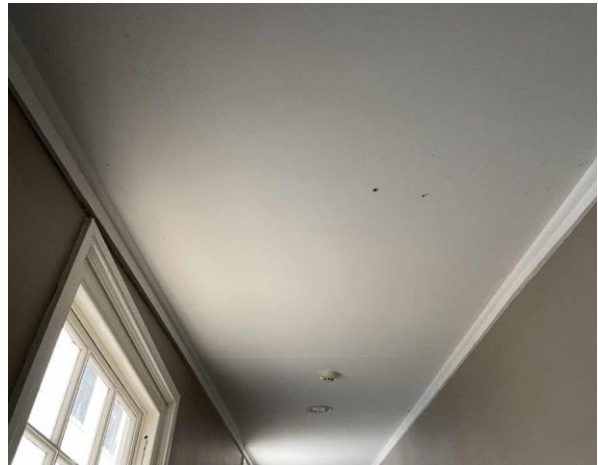
Line ID 20: Internal, Dining Room, Ground Level, Hallway Ramp, Ceiling, Compressed Cement Sheetting - Suspected Asbestos

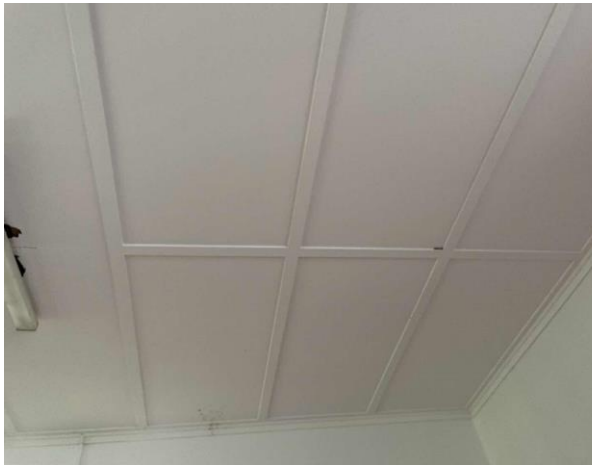
Line ID 21: Internal, Dining Room, Ground Level, Lower Area Ceiling, Compressed Cement Sheetting - Suspected Asbestos

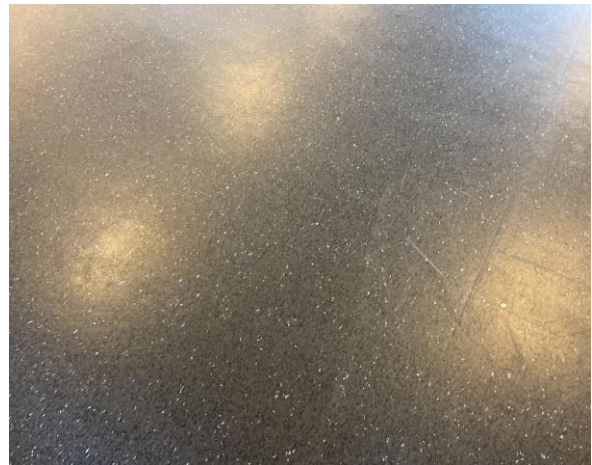
Line ID 22: Internal, Dining Room, Ground Level, Throughout Dining Hall and Bathrooms, Floor Covering, Black Speckled Vinyl Sheet - No Asbestos Detected

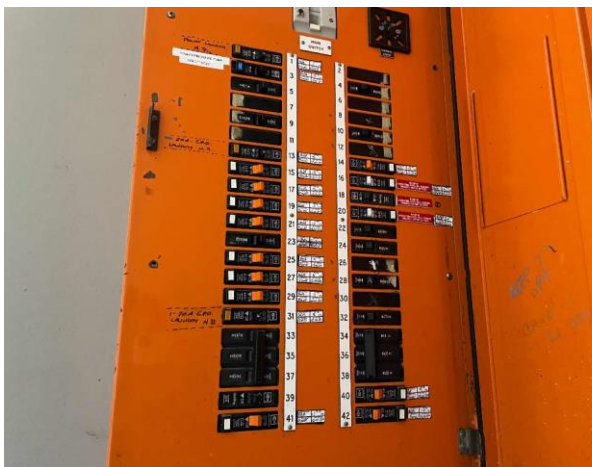
Line ID 23: Internal, Dining Room, Ground Level, Within Wall Mounted Electrical Cupboard, HRC Fuses - Suspected Asbestos

Internal	Dining Room / Ground Level / Within Wall Mounted Electrical Cupboard	HRC Fuses	Asbestos	754-SYDEN311850 230A5	Suspected Asbestos	Friable	10 Units	Low	5 Yearly Reinspection	Not sampled due to live equipment. Confirm status and maintain in current condition if to remain in-situ in accordance with relevant State Regulations, Compliance Codes, Codes of Practice and Guidance Notes. Remove under controlled friable asbestos removal conditions prior to refurbishment or demolition works by a Class A (friable) licensed asbestos removal contractor in accordance with relevant State Regulations, Compliance Codes, Codes of Practice and Guidance Notes.	23

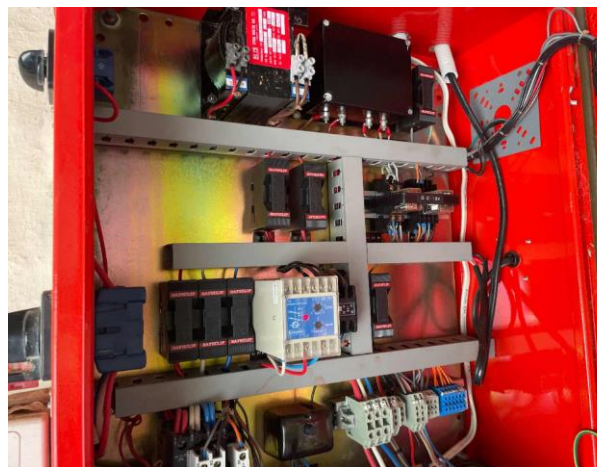
Line ID 24: Internal, Garbage and Fire Pump Room, Ground Floor, Fire Pump Room, Within Wall Mounted Cupboard, HRC Fuses - Suspected Asbestos

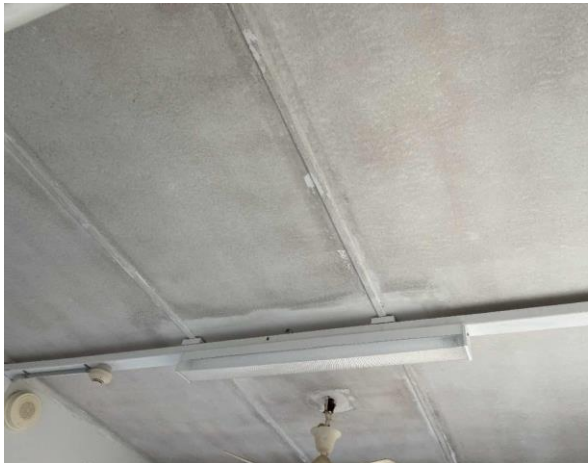
Line ID 25: Internal, Laundry, Ground Floor, to Ceiling Panels, Compressed Cement Sheetting - Suspected Asbestos

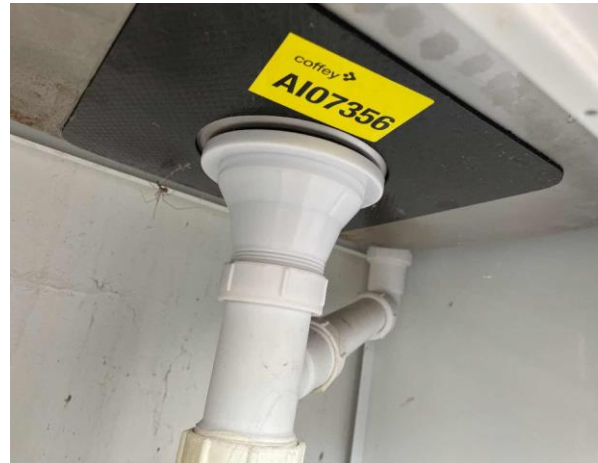
Line ID 26: Internal, Laundry, Ground Floor, Under Laundry Sinks, Sink Pad, Bituminous Membrane - No Asbestos Detected

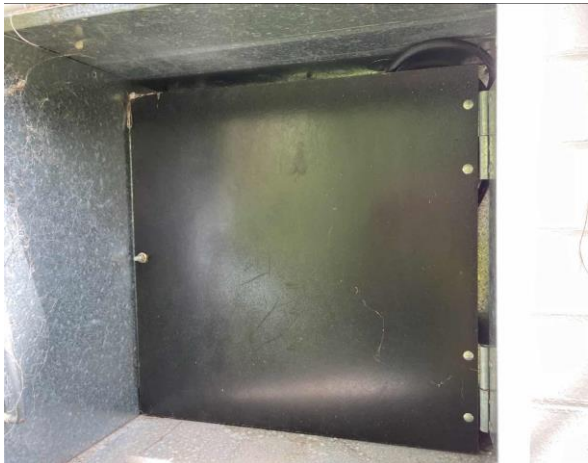
Line ID 27: Internal, Laundry, Ground Floor, Wall Mounted Cupboard, Electrical Board, Bituminous Backing Board - Suspected Asbestos

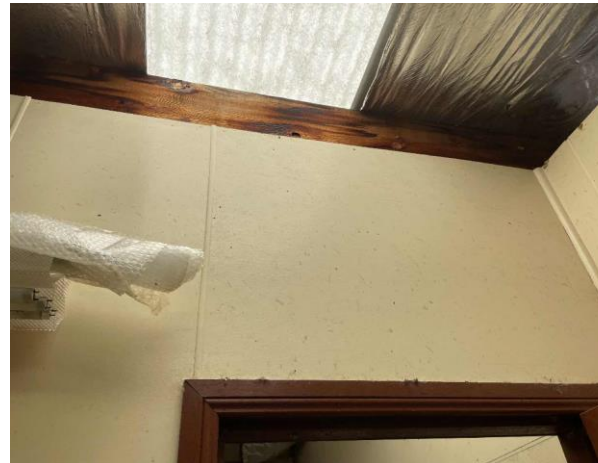
Line ID 28: Internal, Maintenance Shed, Ground Floor, Storage Room, Wall Lining, Compressed Cement Sheetting - No Asbestos Detected

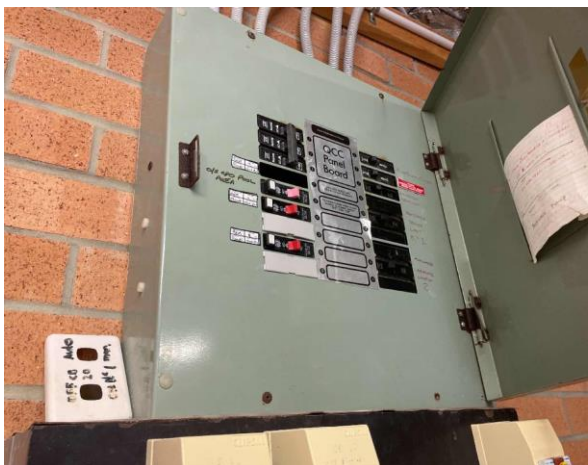
Line ID 29: Internal, Pool Pump and Storerooms, Ground Floor, Wall Mounted Cupboard, HRC Fuses - Suspected Asbestos

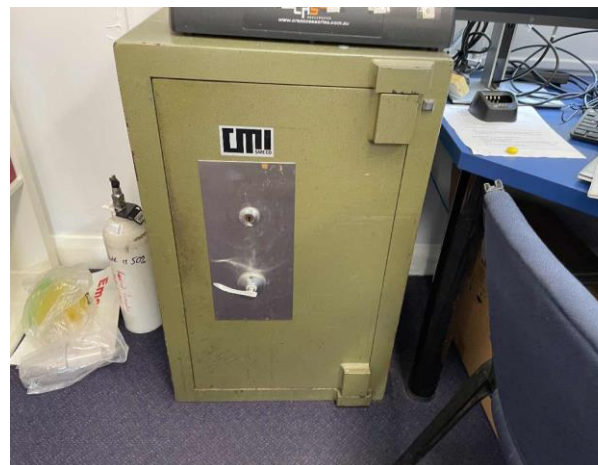
Line ID 30: Internal, Reception, Ground Floor, East Elevation of Reception, Safe, Internal Insulation - Suspected Asbestos

Internal	Reception / Ground Floor / East Elevation of Reception, Safe	Internal Insulation	Asbestos	754-SYDEN311850 230A9	Suspected Asbestos	Friable	1 Unit	Low	5 Yearly Reinspection	Confirm status and maintain in current condition if to remain in-situ in accordance with relevant State Regulations, Compliance Codes, Codes of Practice and Guidance Notes. Remove under controlled friable asbestos removal conditions prior to refurbishment or demolition works by a Class A (friable) licensed asbestos removal contractor in accordance with relevant State Regulations, Compliance Codes, Codes of Practice and Guidance Notes.	30
Internal	Reception / Ground Floor / Store and Redundant Bathroom Walls	Corrugated Cement Sheet	Asbestos	AI07357	Chrysotile, Amosite and Crocidolite Asbestos Detected	Non-Friable	20 m²	Low	5 Yearly Reinspection	Maintain in current condition if to remain in-situ. Remove under controlled non-friable asbestos removal conditions prior to refurbishment or demolition works by a Class B (non-friable) licensed asbestos removal contractor in accordance with relevant State	31

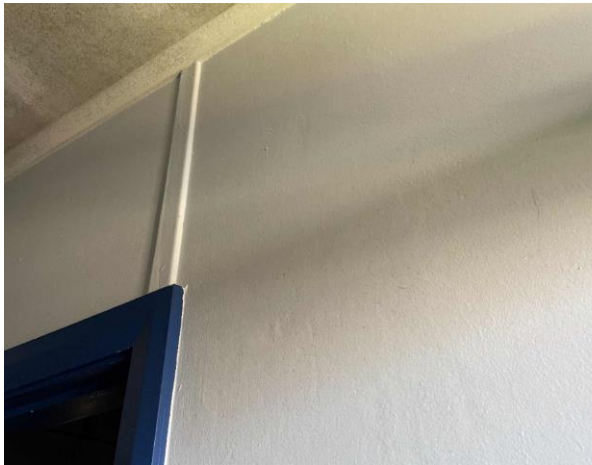
Line ID 31: Internal, Reception, Ground Floor, Store and Redundant Bathroom Walls, Corrugated Cement Sheet - Chrysotile, Amosite and Crocidolite Asbestos Detected

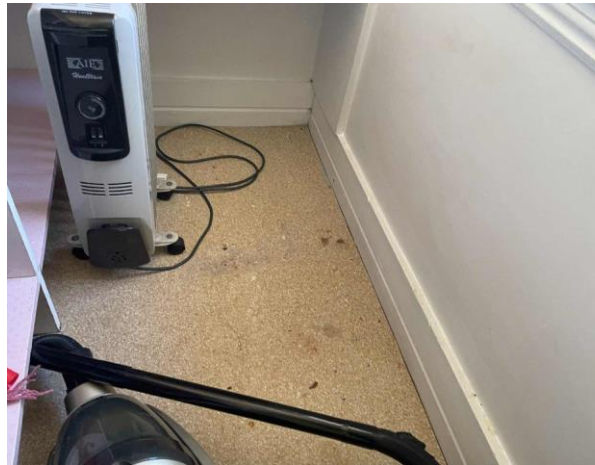
Line ID 32: Internal, Staff Residence, Ground Floor, Pantry Room, Vinyl Sheet - No Asbestos Detected

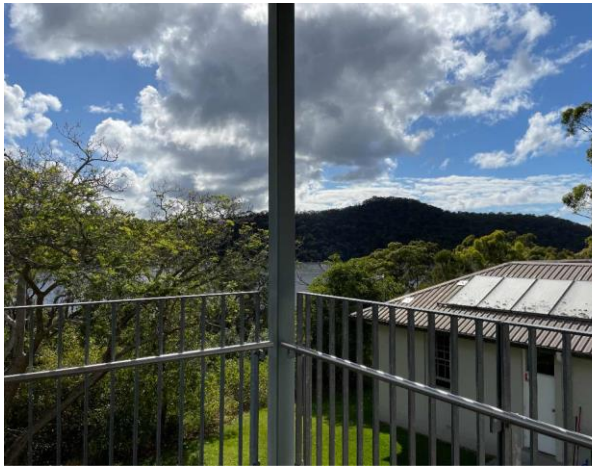
Line ID 33: External, Dining Room, Throughout, East Undercover Dining Area, Poles, Blue (Light) Paint - Lead Detected ($<0.005\%$ w/w)

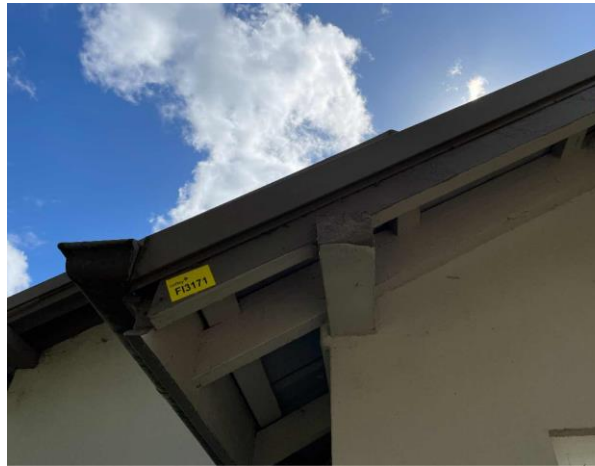
Line ID 34: External, Dining Room, Throughout, Gables, Brown Paint - Lead Detected (1.3% w/w)

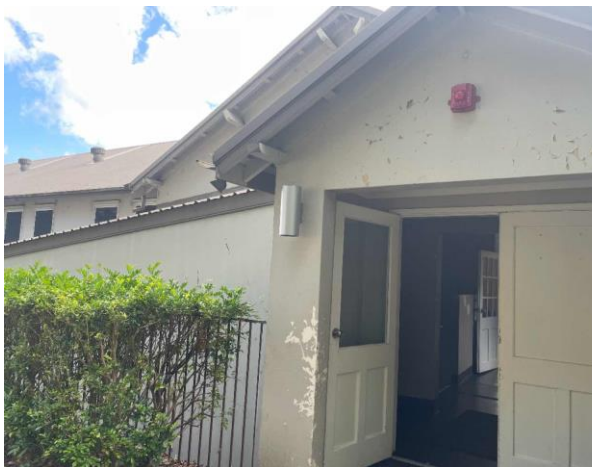
Line ID 35: External, Dining Room, Throughout, Walls, Grey (Light) Paint - Lead Detected (15% w/w)

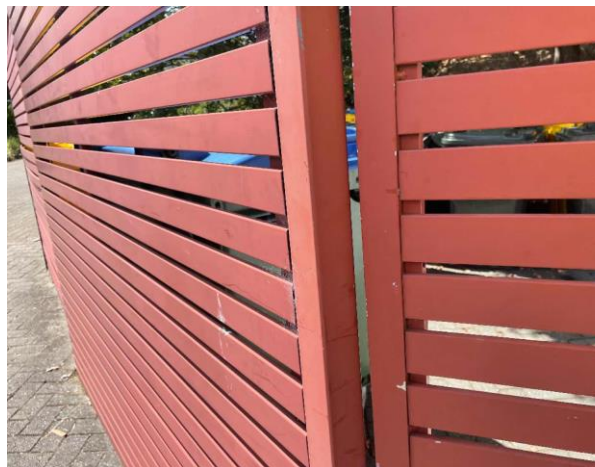
Line ID 36: External, Garbage and Fire Pump Rooms, Ground Floor, Garbage Bins Fence, Red Paint - Lead Detected ($<0.005\%$ w/w)

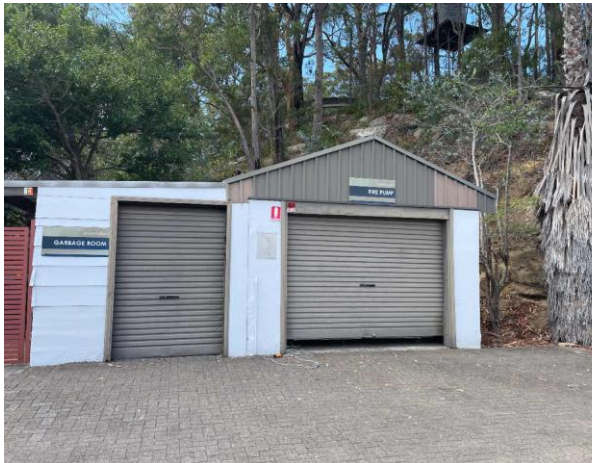
Line ID 37: External, Garbage and Fire Pump Rooms, Ground Floor, Walls, White Paint - Lead Detected (<0.005% w/w)

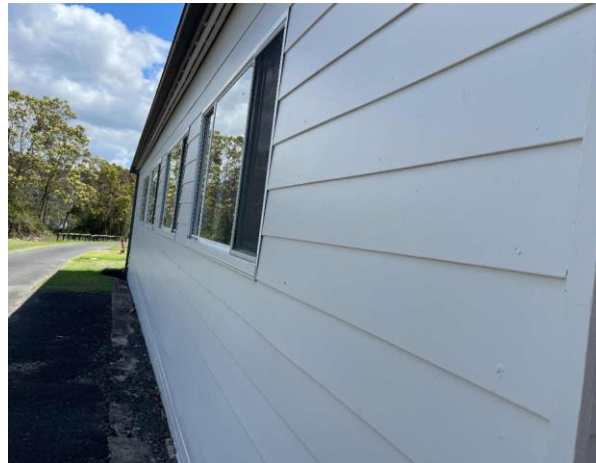
Line ID 38: External, Platypus Lodge, Ground Floor, Walls, White Paint - Lead Detected (<0.005% w/w)

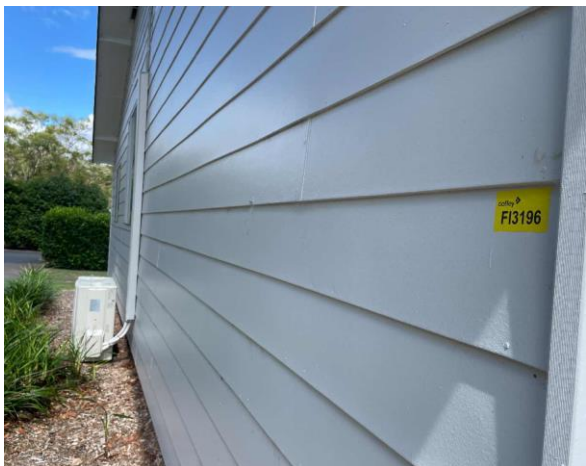
Line ID 39: External, Reception, Ground Floor, Walls, White Paint - Lead Detected (<0.005% w/w)

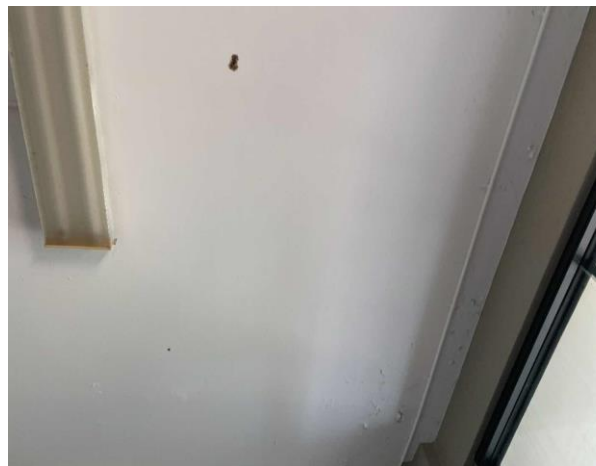
Line ID 40: Internal, Craft Room, Ground Floor, Ceiling, White Paint - Suspected Lead

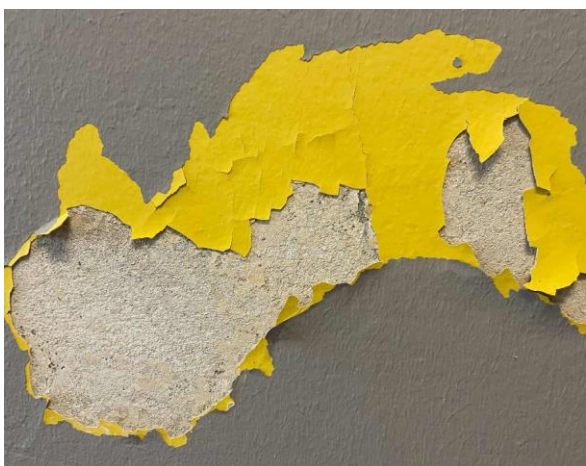
Line ID 41: Internal, Dining Room, Ground Level, Adjacent Entrance to Craft Area, Lower Layer Paint, Yellow Paint - Lead Detected (0.60% w/w)

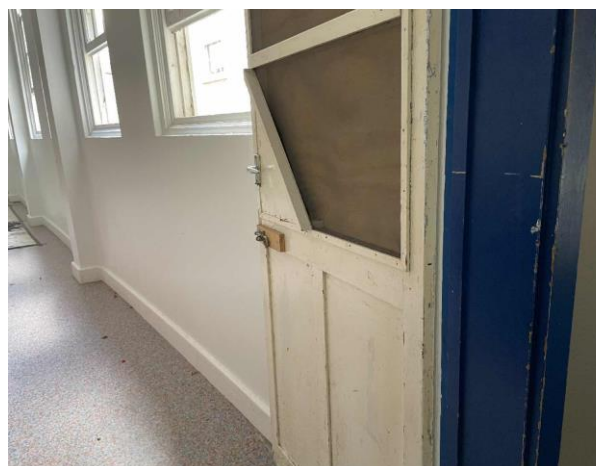
Line ID 42: Internal, Dining Room, Ground Level, Lower Area Entrance Door, White Paint - Lead Detected (0.006% w/w)

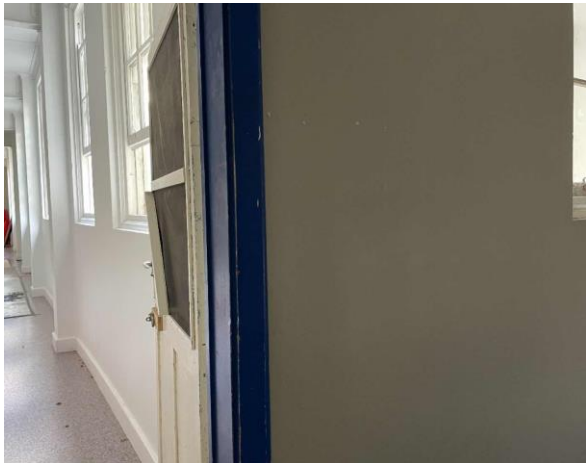
Line ID 43: Internal, Dining Room, Ground Level, Lower Area Entrance, Door Frame, Blue (Dark) Paint - Lead Detected (0.051% w/w)

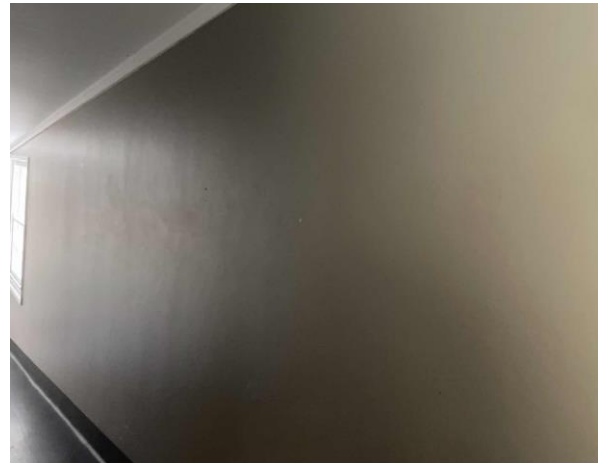
Line ID 44: Internal, Dining Room, Level 1, Adjacent Entrance and Corridor, Walls, Grey (Dark) Paint - Lead Detected (3.3% w/w)

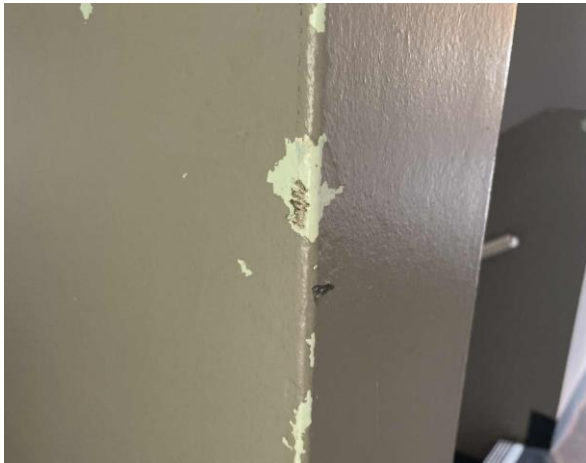
Line ID 45: Internal, Dining Room, Level 1, s Adjacent Entrance and Corridor, Lower Layer Paint to Wall, Cream Paint - Lead Detected (2.3% w/w)

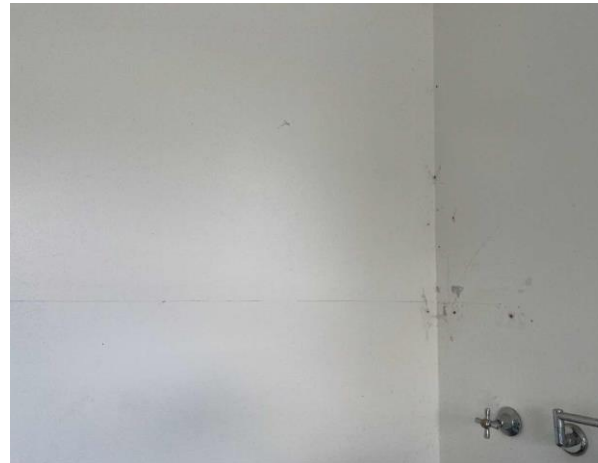
Line ID 46: Internal, Laundry, Ground Floor, Walls, White Paint - Lead Detected (<0.005% w/w)

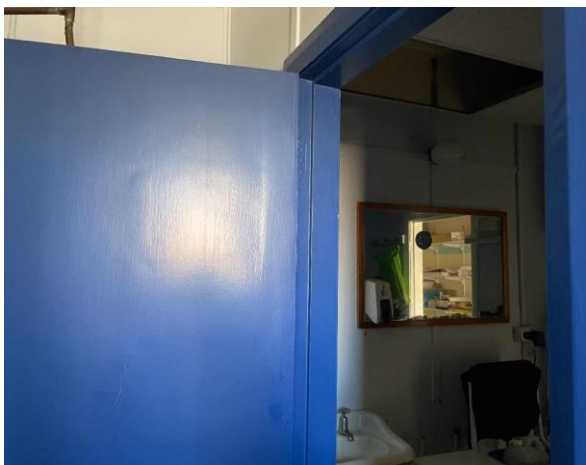
Line ID 47: Internal, Reception, Ground Floor, Redundant Bathroom Doors and Frames, Blue (Dark) Paint - Lead Detected (0.051% w/w)

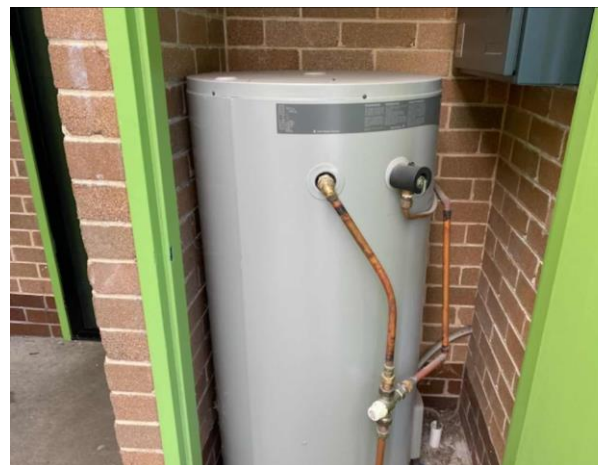
Line ID 48: External, Accommodation Lodges, Lorikeet, Kookaburra, Waratah, Koala and Possum, Within Cupboard, Hot Water Heater, Insulation Material - Suspected SMF

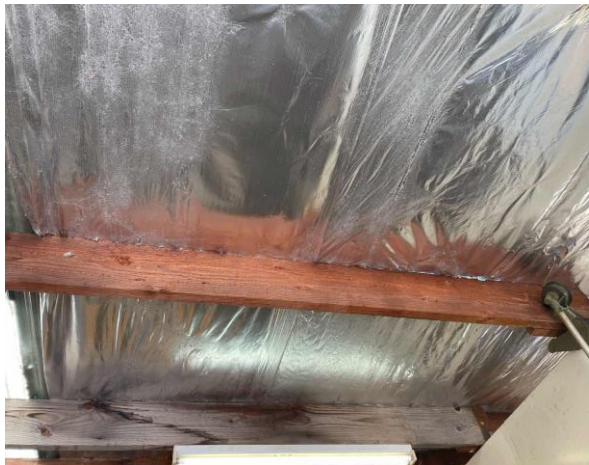
Line ID 49: External, Maintenance Shed, Ground Floor, Underside of Roof, Sarking Insulation - Suspected SMF

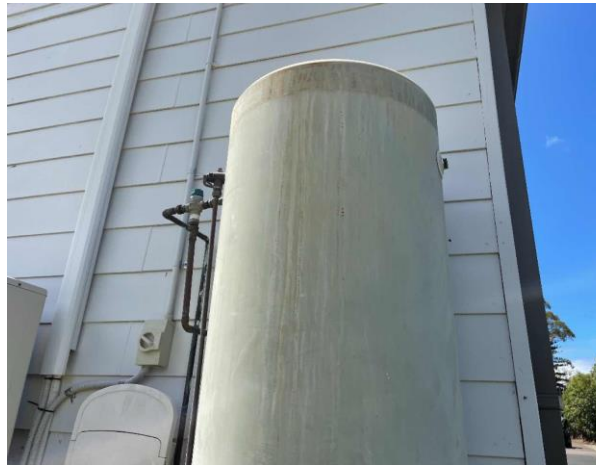
Line ID 50: External, Platypus Lodge, Ground Floor, West Elevation, Hot Water Heater, Insulation Material - Suspected SMF

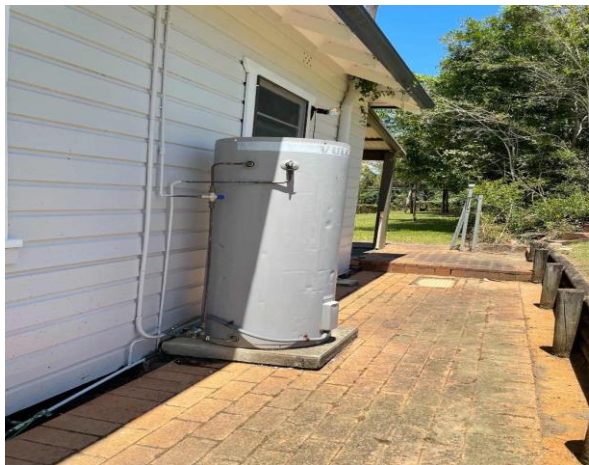
Line ID 51: External, Staff Residence, Ground Floor, West Elevation, Hot Water Heater, Insulation Material - Suspected SMF

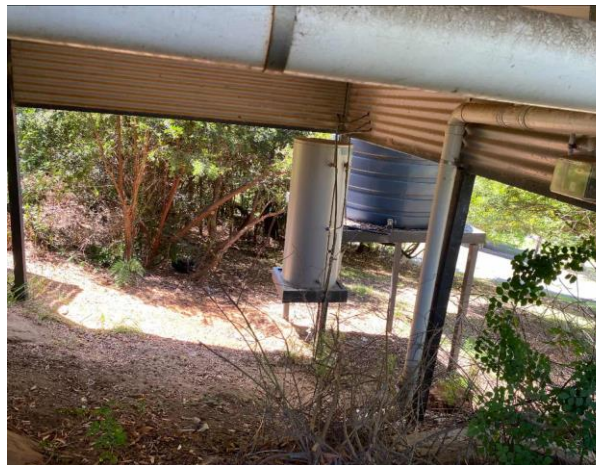
Line ID 52: External, Units 1-5, Ground Floor, Adjacent Water Tanks, Hot Water Heater, Insulation Material - Suspected SMF

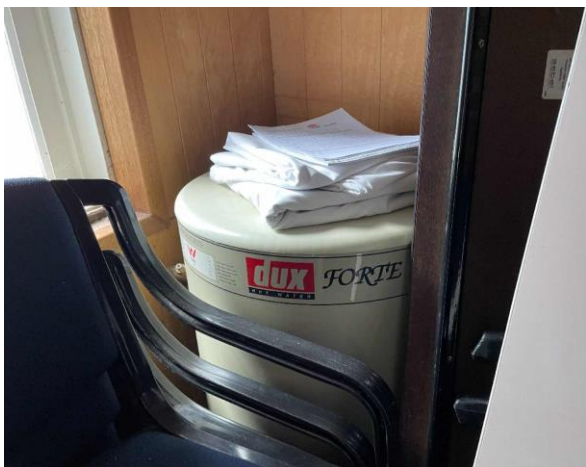
Line ID 53: Internal, Conference Room, Ground Floor, Conference Storeroom, Hot Water Heater, Insulation Material - Suspected SMF

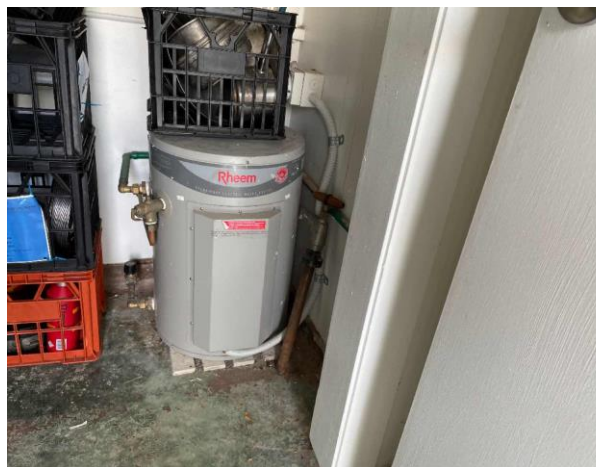
Line ID 54: Internal, Laundry, Ground Floor, Laundry Storeroom, Hot Water Heater, Insulation Material - Suspected SMF

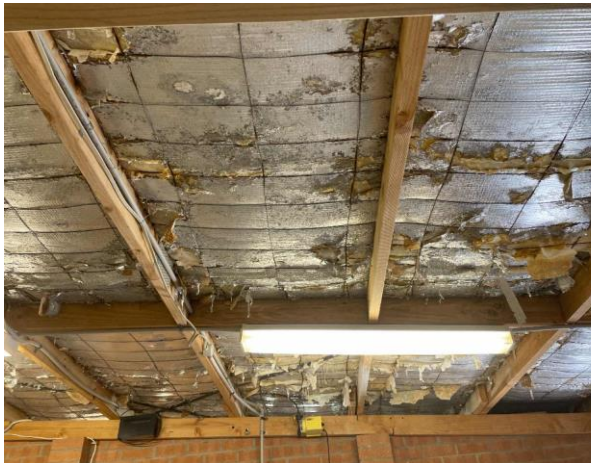
Line ID 55: Internal, Pool Pump and Storerooms, Ground Floor, Underside of Roof, Sarking Insulation - Suspected SMF

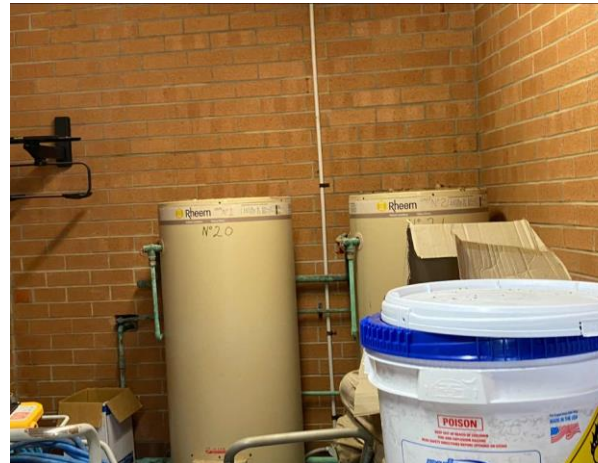
Line ID 56: Internal, Pool Pump and Storerooms, Ground Floor, Within Storeroom, Hot Water Heater, Insulation Material - Suspected SMF

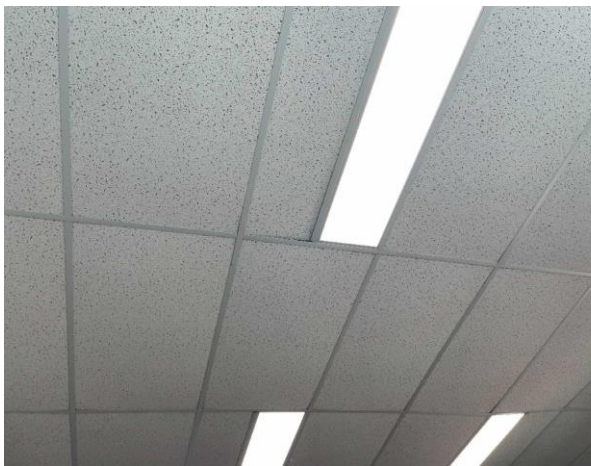
Line ID 57: Internal, Reception, Ground Floor, Reception Area, Ceiling, Compressed Ceiling Tiles - Suspected SMF

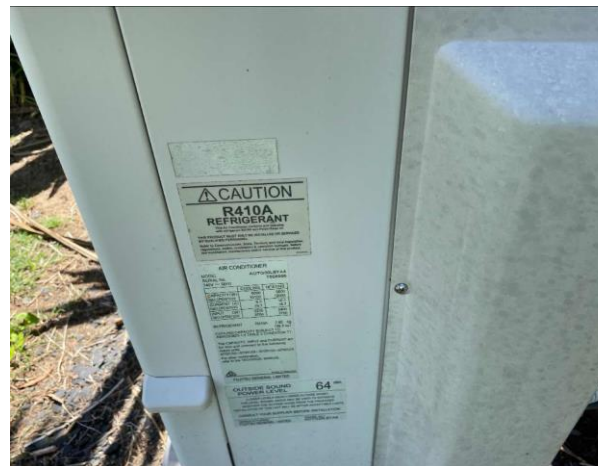
Line ID 58: External, Accommodation Lodges, Lorikeet, Kookaburra, Waratah, Koala and Possum, Air Conditioning Unit, R410A Hydrofluorocarbon (HFC) - Non ODS Refrigerant

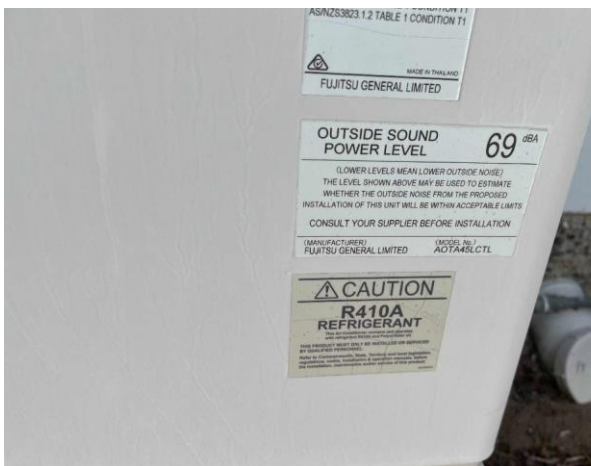
Line ID 59: External, Platypus Lodge, Ground Floor, West Elevation, Air Conditioning Unit, R410A Hydrofluorocarbon (HFC) - Non ODS Refrigerant

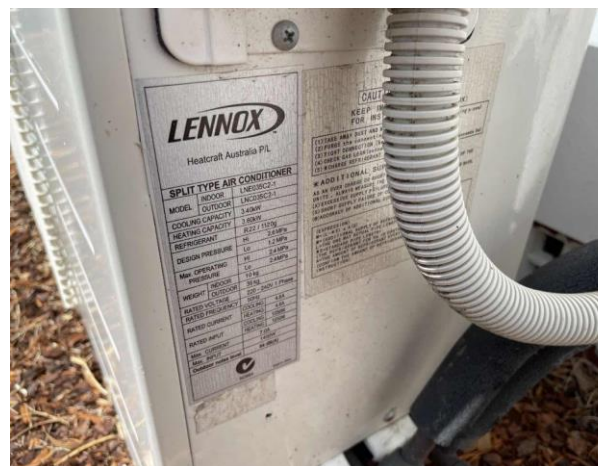
Line ID 60: External, Reception, Ground Floor, North-East Elevation, Air Conditioning Unit, R22 Hydrochlorofluorocarbon (HCFC) - ODS Refrigerant

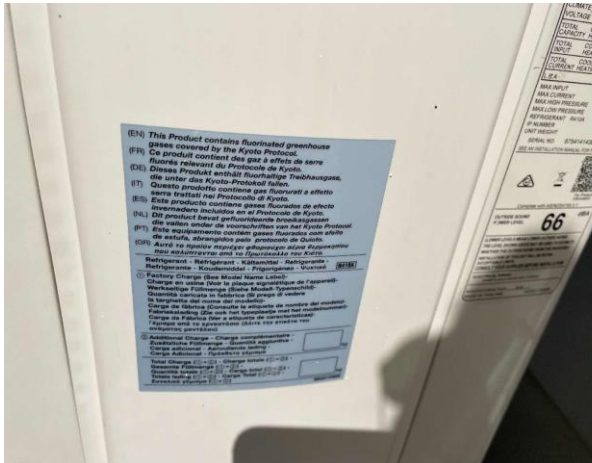
Line ID 61: External, Reception, Ground Floor, South-East Elevation, Air Conditioning Unit, R410A Hydrofluorocarbon (HFC) - Non ODS Refrigerant

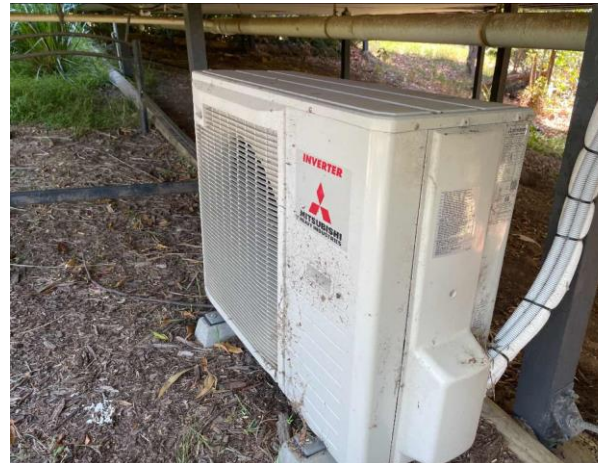
Line ID 62: External, Units 1-5, Ground Floor, Air Conditioning Unit, R410A Hydrofluorocarbon (HFC) - Non ODS Refrigerant

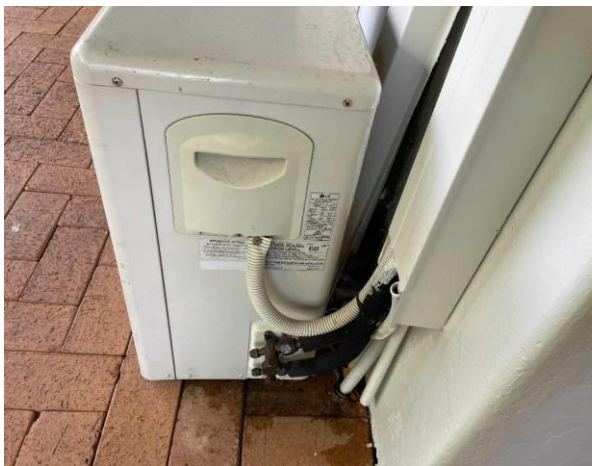
Line ID 63: Internal, Conference Room, Ground Floor, East Elevation, Air Conditioning Unit, R22 Hydrochlorofluorocarbon (HCFC) - ODS Refrigerant

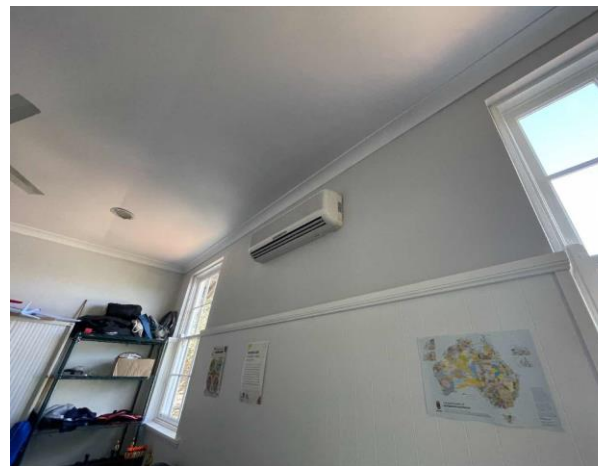
Line ID 64: Internal, Conference Room, Ground Floor, South Elevation, Air Conditioning Unit, Unknown Refrigerant - Suspected ODS

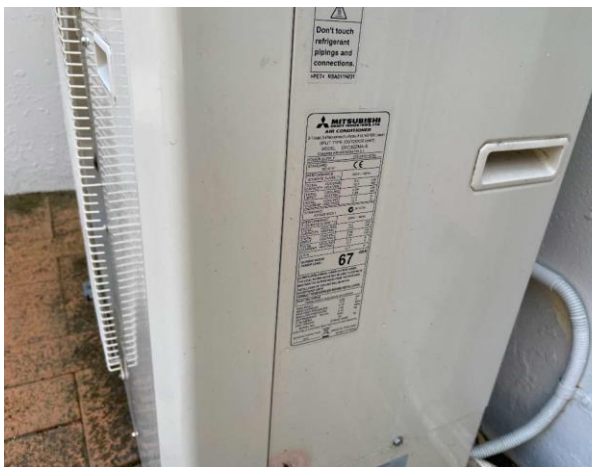
Line ID 65: Internal, Conference Room, Ground Floor, West Elevation, Air Conditioning Unit, R410A Hydrofluorocarbon (HFC) - Non ODS Refrigerant

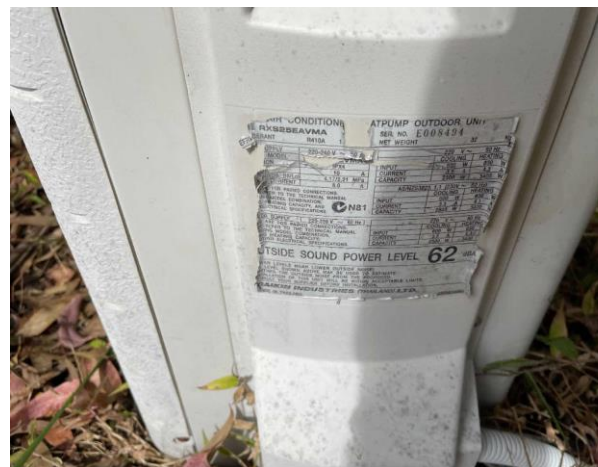
Line ID 66: Internal, Laundry, Ground Floor, South Elevation, Air Conditioning Unit, R410A Hydrofluorocarbon (HFC) - Non ODS Refrigerant
