# Asbestos and Hazardous Materials Reinspection Assessment

Berry Sports & Recreation Centre

84 Albany Street

25/01/2023

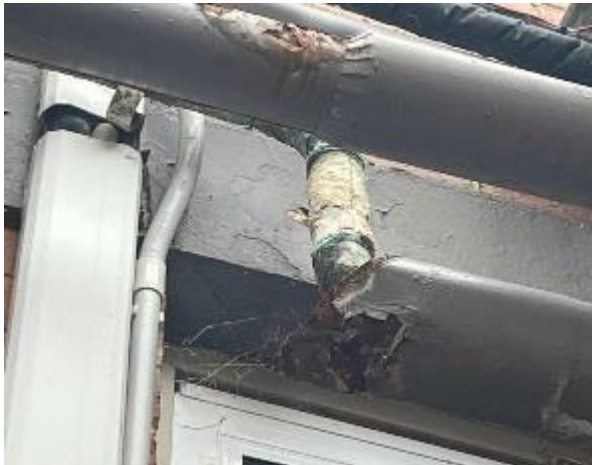
Line ID 1: External, Accommodation Building, Adjacent Boiler House, Pipes to High Level, Lagging Debris - Amosite Asbestos Detected

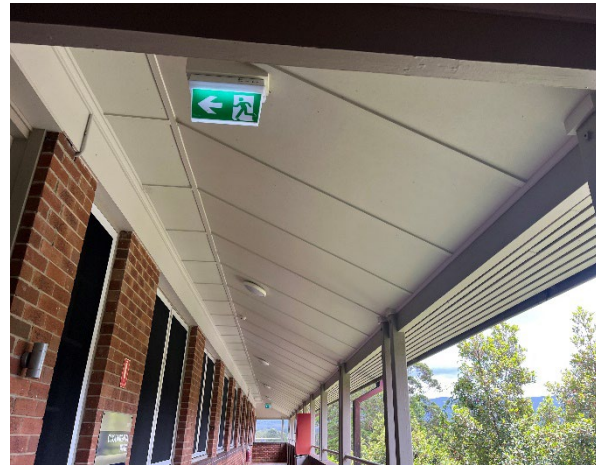
Line ID 2: External, Accommodation Building, Coolangatta, Veranda Ceiling, Fibre Cement Sheet - Chrysotile, Amosite and Crocidolite Asbestos Detected

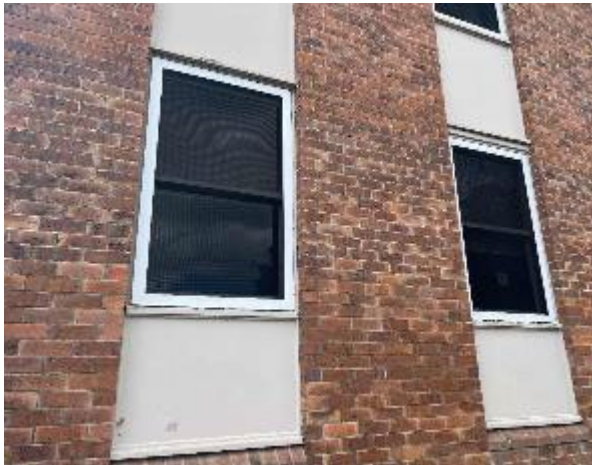
Line ID 3: External, Accommodation Building, Staff Accommodation, Above and Below Windows, Infill Panels, Fibre Cement Sheet - Chrysotile Asbestos Detected

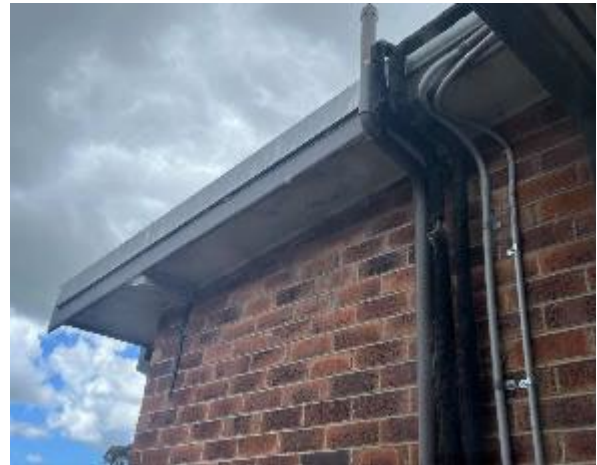
Line ID 4: External, Accommodation Building, Staff Accommodation, Eave Lining, Fibre Cement Sheet - Suspected Asbestos

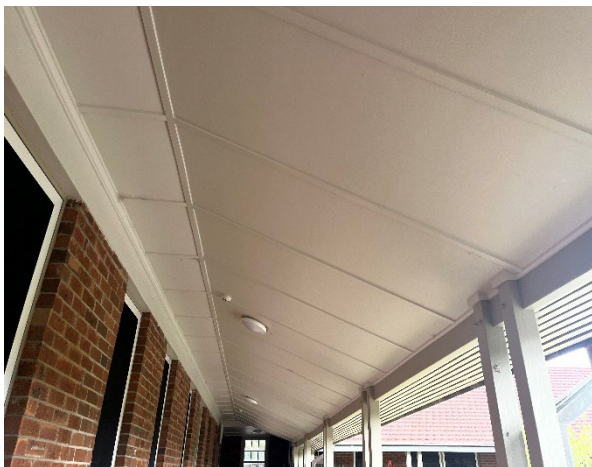
Line ID 5: External, Accommodation Building, Watson & Shoalhaven, Veranda Ceiling, Fibre Cement Sheet - Chrysotile, Amosite and Crocidolite Asbestos Detected

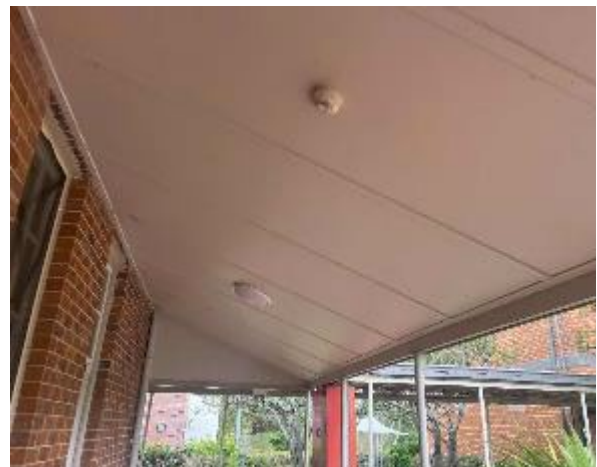
Line ID 6: External, Admin Building, Entry Area and Covered Walkways, Awning Lining, Fibre Cement Sheet - Chrysotile, Amosite and Crocidolite Asbestos Detected

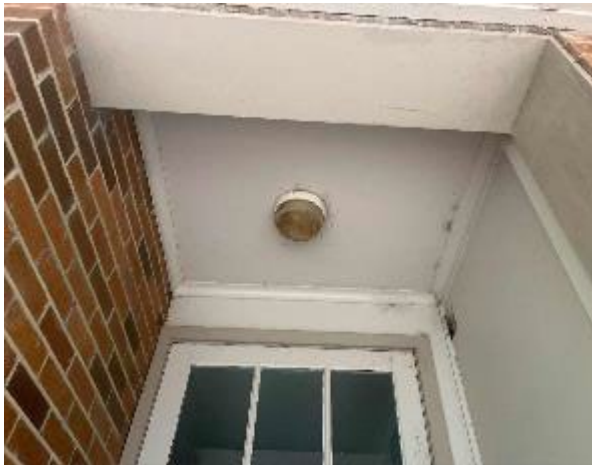
Line ID 7: External, Admin Building, Entry Area and Covered Walkways, Porch Ceiling Lining, Fibre Cement Sheet - Chrysotile, Amosite and Crocidolite Asbestos Detected

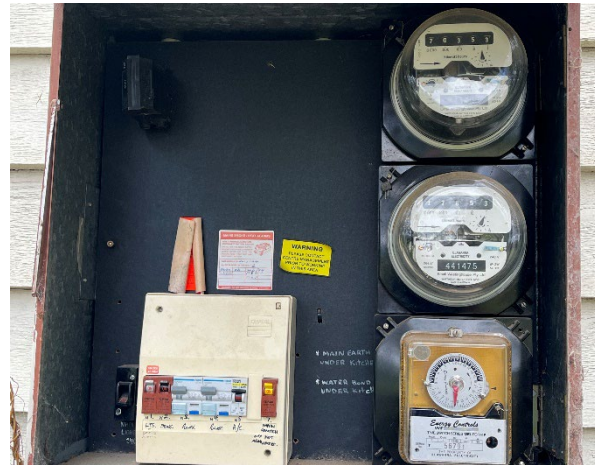
Line ID 9: External, North Residence, Verandas, Side of House, Fuse Box, Electrical Backing Board - Suspected Asbestos

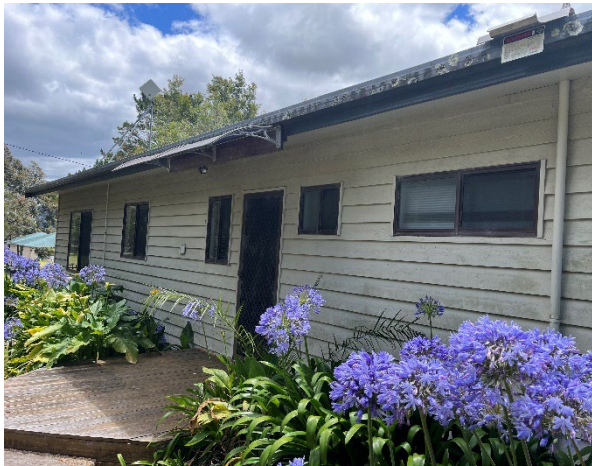
Line ID 10: External, North Residence, Verandas, Wall and Eave Linings, Fibre Cement Sheet - No Asbestos Detected

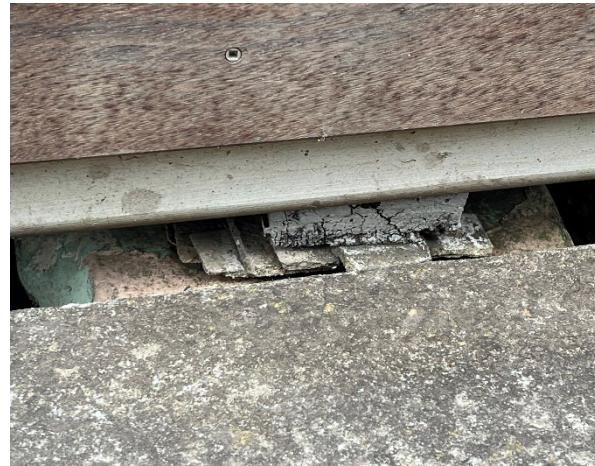
Line ID 12: External, South Residence, Verandas, Packers to Timber Deck, Fibre Cement Sheet - Chrysotile Asbestos Detected

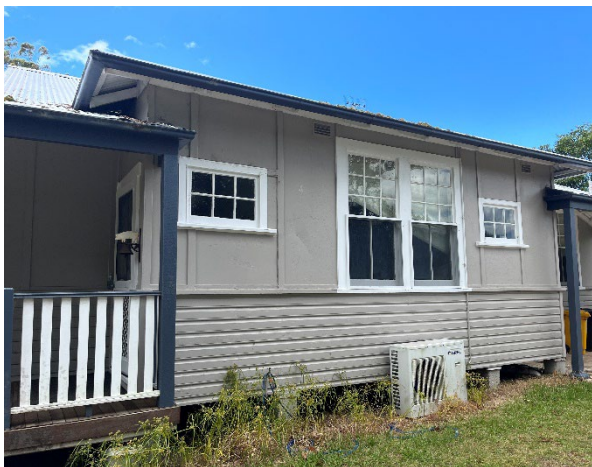
Line ID 13: External, South Residence, Verandas, Wall Cladding, Fibre Cement Sheet - Chrysotile & Amosite Asbestos Detected

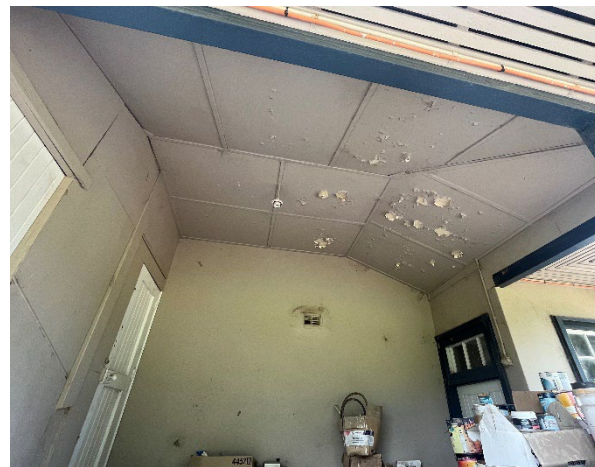
Line ID 14: External, Workshop and Silo, Maintenance Shed and Offices, Eave Lining, Fibre Cement Sheet - Chrysotile, Amosite and Crocidolite Asbestos Detected

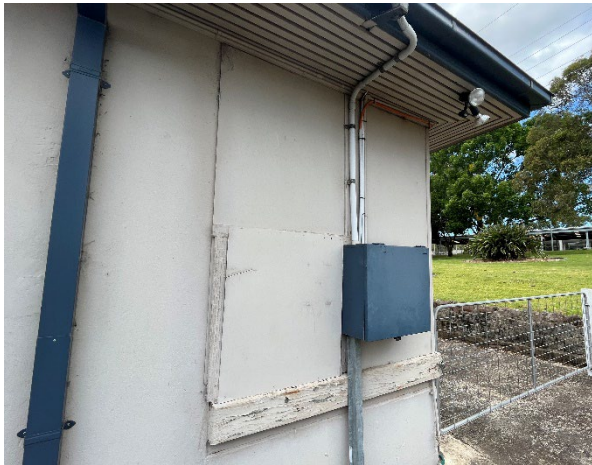
Line ID 15: External, Workshop and Silo, Maintenance Shed and Offices, South Elevation, Wall Lining, Fibre Cement Sheet - Chrysotile, Amosite and Crocidolite Asbestos Detected

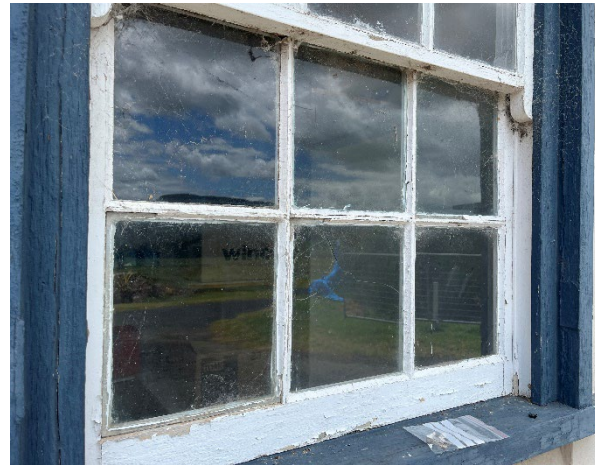
Line ID 16: External, Workshop and Silo, Maintenance Shed and Offices, Timber Windows Throughout, Window Caulking - No Asbestos Detected

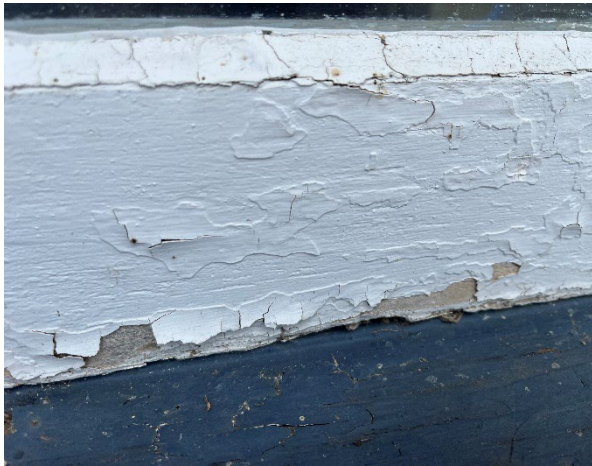
Line ID 16.1: External, Workshop and Silo, Maintenance Shed and Offices, Timber Windows Throughout, Window Caulking - No Asbestos Detected

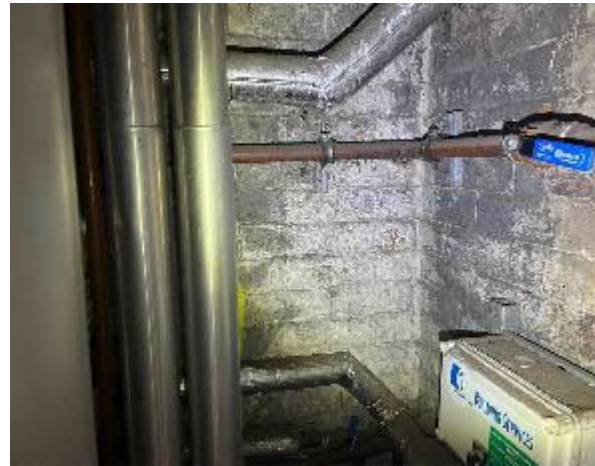
Line ID 17: Internal, Accommodation Building, Boiler House, Behind Paint to Walls, Lagging Debris - Amosite Asbestos Detected

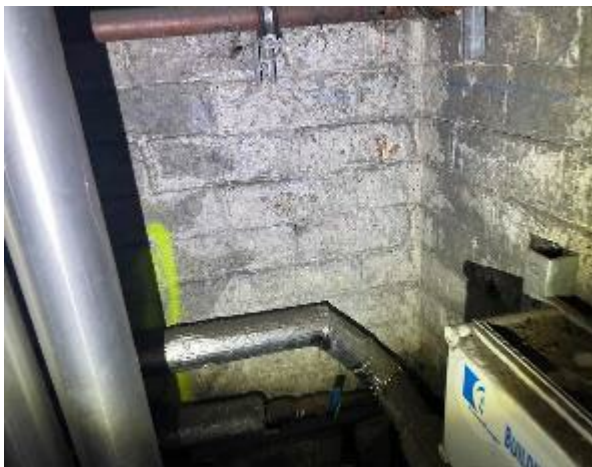
Line ID 17.1: Internal, Accommodation Building, Boiler House, Behind Paint to Walls, Lagging Debris - Amosite Asbestos Detected

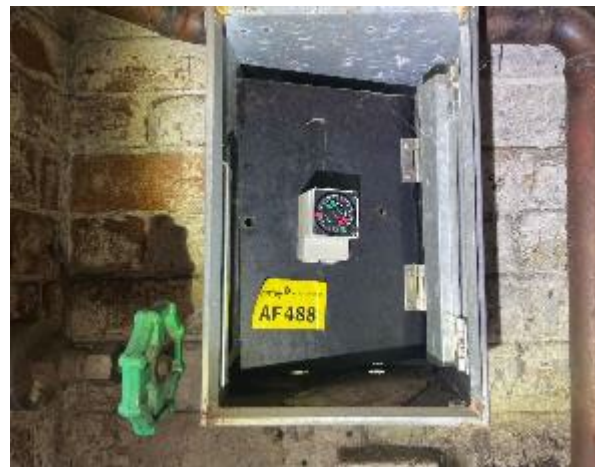
Line ID 18: Internal, Accommodation Building, Boiler House, Electrical Box Behind Water Heater, Bituminous Backing Board - Chrysotile Asbestos Detected

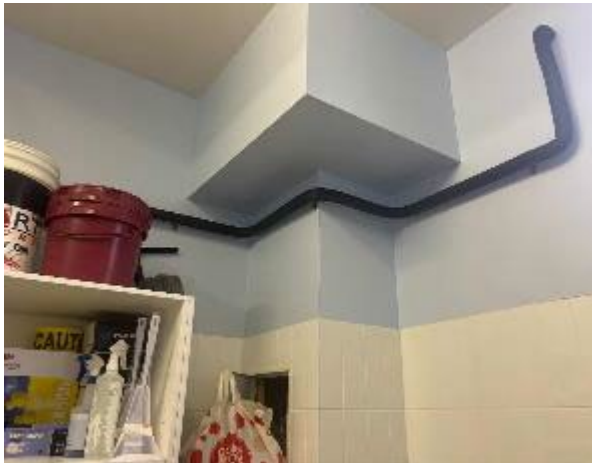
Line ID 23: Internal, Accommodation Building, GF Cleaners Room, High Level Boxing, Fibre Cement Sheet - No Asbestos Detected

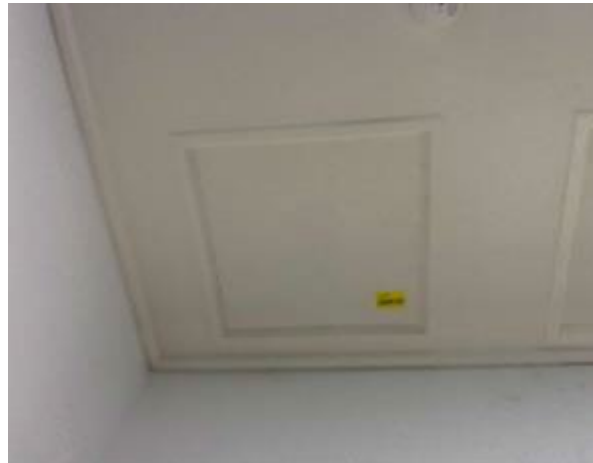
Line ID 24: Internal, Accommodation Building, GF Disabled Male Toilet, Ceiling Hatch, Fibre Cement Sheet - No Asbestos Detected

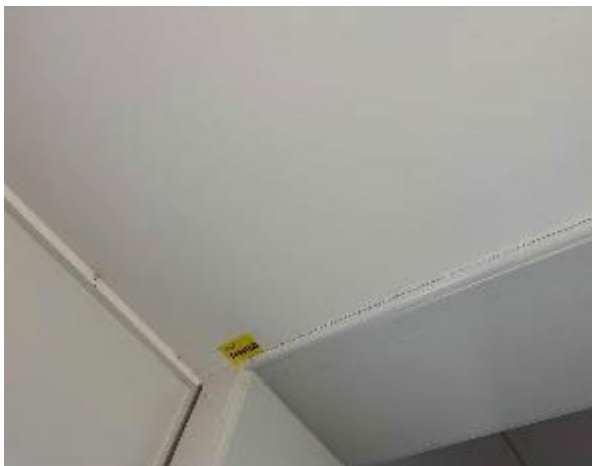
Line ID 30: Internal, Accommodation Building, L1 Corridor to Staff Accommodation, Ceiling Lining, Compressed Cement Sheet - No Asbestos Detected

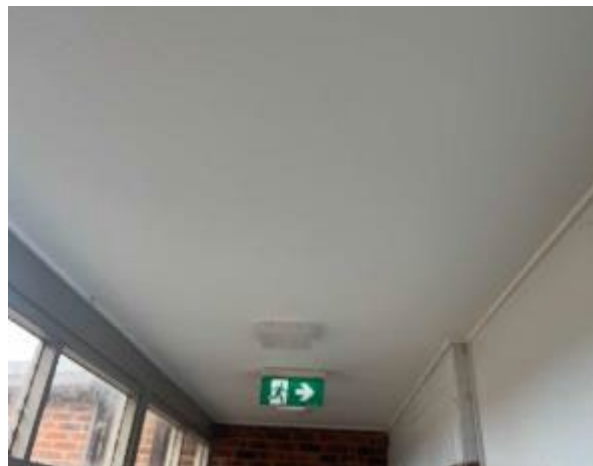
Line ID 30.1: Internal, Accommodation Building, L1 Corridor to Staff Accommodation, Ceiling Lining, Compressed Cement Sheet - No Asbestos Detected

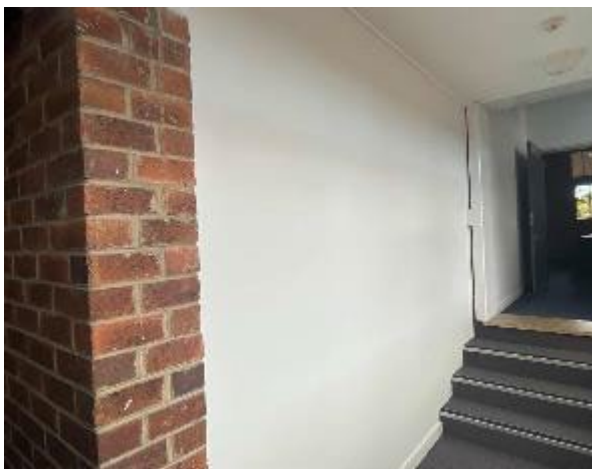
Line ID 31: Internal, Accommodation Building, L1 Corridor to Staff Accommodation, Wall Lining, Compressed Cement Sheet - No Asbestos Detected

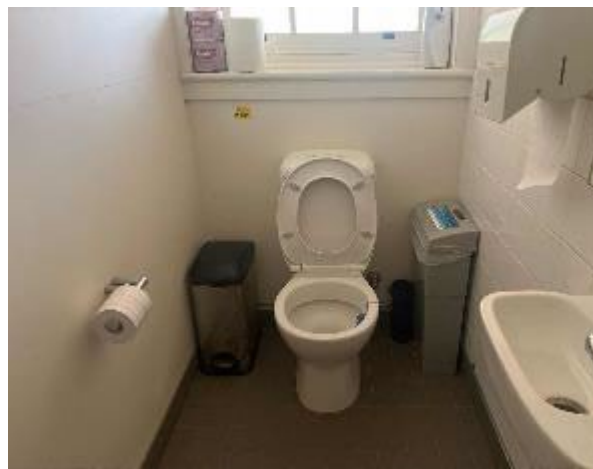
Line ID 37: Internal, Admin Building, Ladies Toilet, Wall Lining, Fibre Cement Sheet - No Asbestos Detected

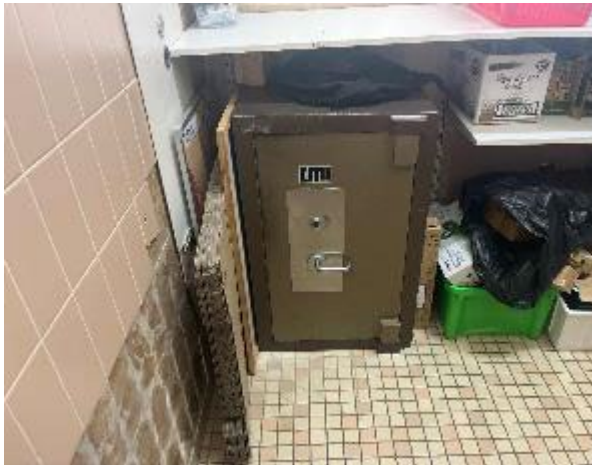
Line ID 38: Internal, Admin Building, Storeroom, CMI Safe, Internal Insulation - Suspected Asbestos

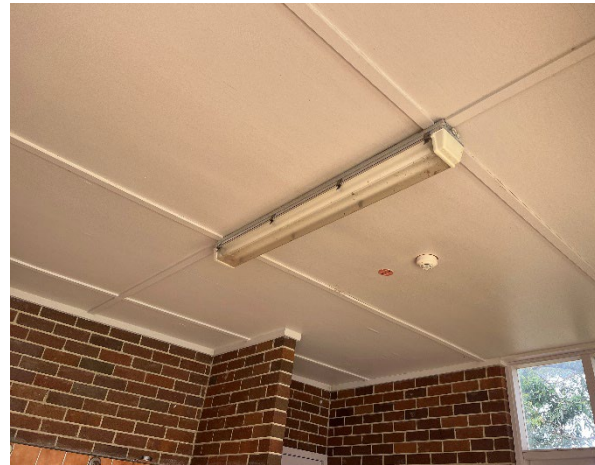
Line ID 41: Internal, Pool House, Throughout, Shower Area, Ceiling, Fibre Cement Sheet - No Asbestos Detected

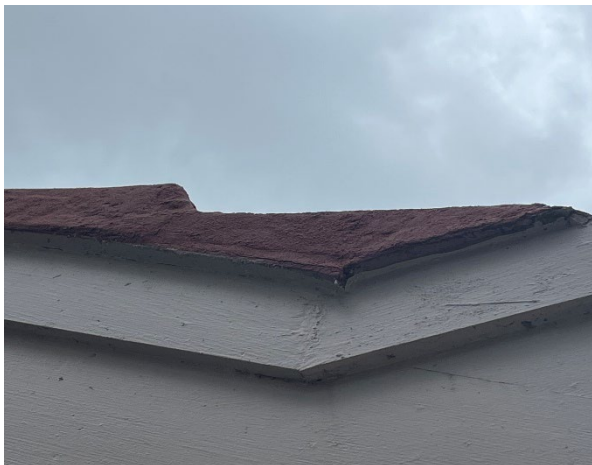
Line ID 42: Internal, Pool House, Throughout, Verge Lining to Roof Tiles, Fibre Cement Sheet - No Asbestos Detected

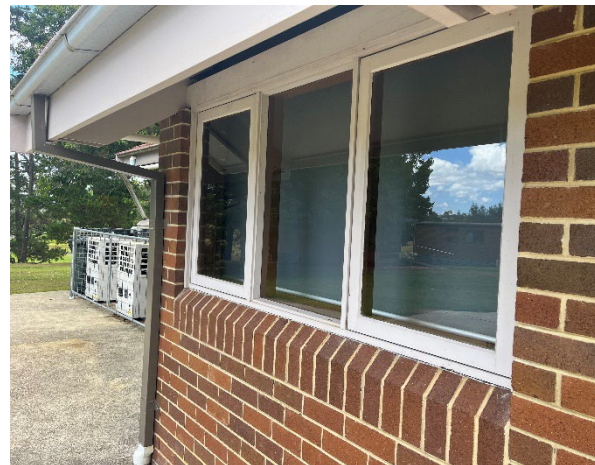
Line ID 43: Internal, Pool House, Throughout, Window Frames, Window Caulking - No Asbestos Detected

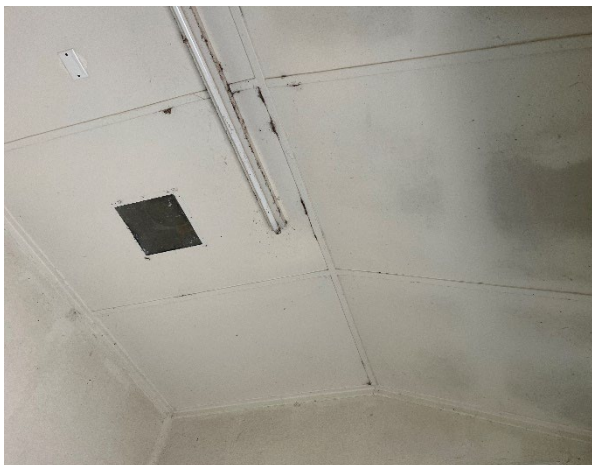
Line ID 50: Internal, Workshop and Silo, Maintenance Shed, Maintenance Building, Ceiling Lining, Fibre Cement Sheet - Chrysotile, Amosite and Crocidolite Asbestos Detected

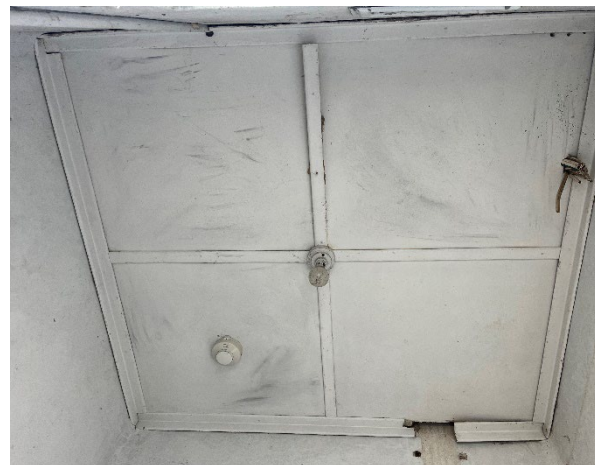
Line ID 50.1: Internal, Workshop and Silo, Maintenance Shed, Maintenance Building, Ceiling Lining, Fibre Cement Sheet - Chrysotile, Amosite and Crocidolite Asbestos Detected

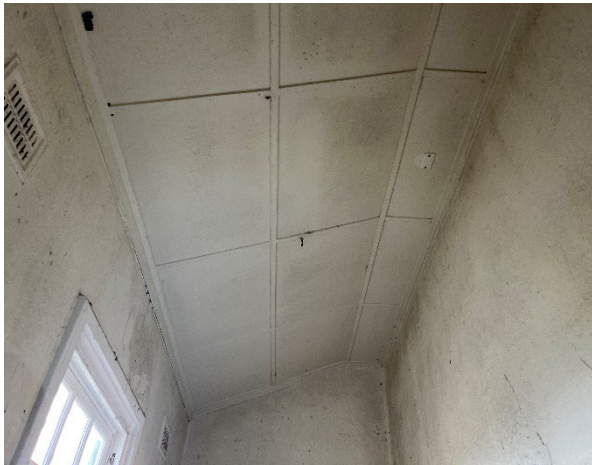
Line ID 50.2: Internal, Workshop and Silo, Maintenance Shed, Maintenance Building, Ceiling Lining, Fibre Cement Sheet - Chrysotile, Amosite and Crocidolite Asbestos Detected

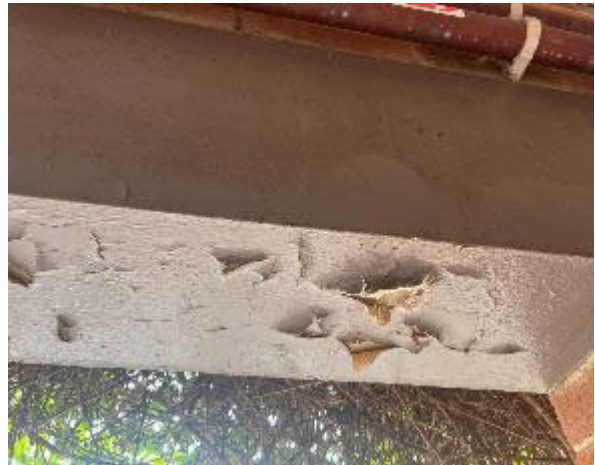
Line ID 51: External, Accommodation Building, Covered Walkway, High Level Bricks, Dark Blue Paint - Lead Detected (3.8% w/w)

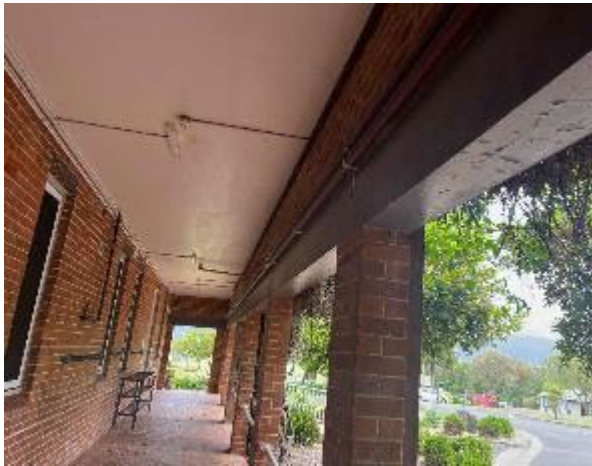
Line ID 51.1: External, Accommodation Building, Covered Walkway, High Level Bricks, Dark Blue Paint - Lead Detected (3.8% w/w)

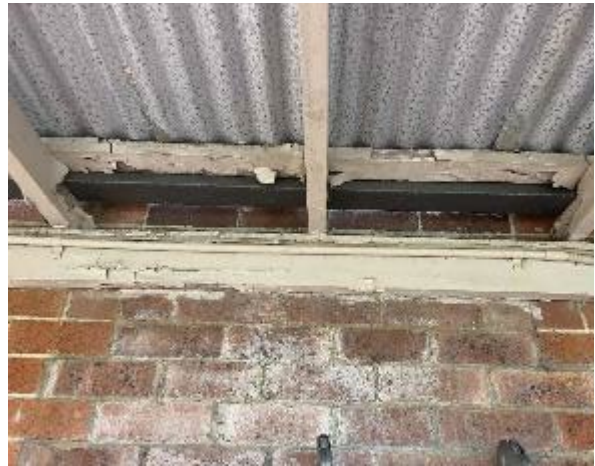
Line ID 52: External, Accommodation Building, Covered Walkway, Timber Work of Metal Roof Section, Beige Paint - Lead Detected (0.26% w/w)

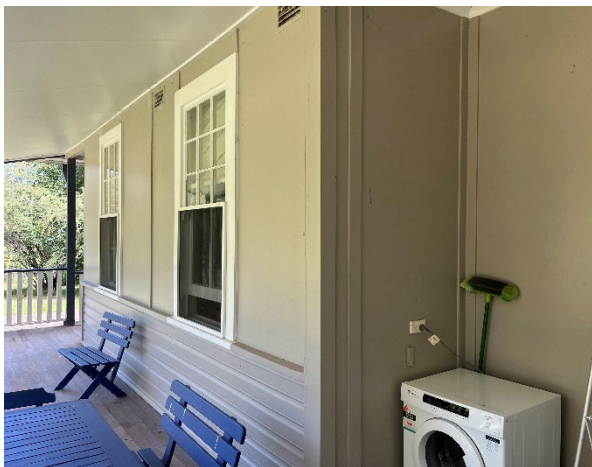
Line ID 53: External, South Residence, Verandas, Walls, White Paint - Lead Detected (9.5% w/w)

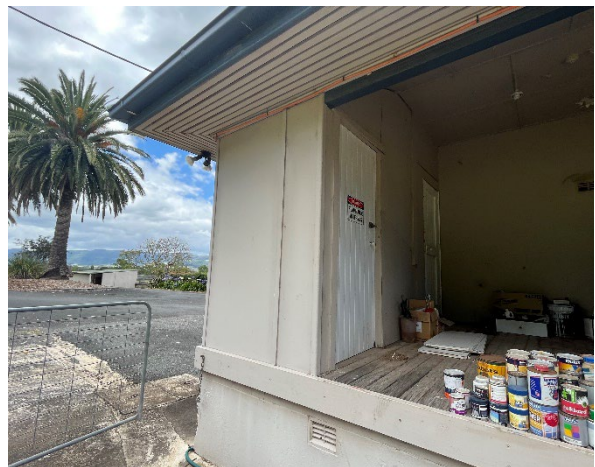
Line ID 54: External, Workshop and Silo, Maintenance Shed and Offices, Wall Linings, White Paint - Lead Detected (3.2% w/w)

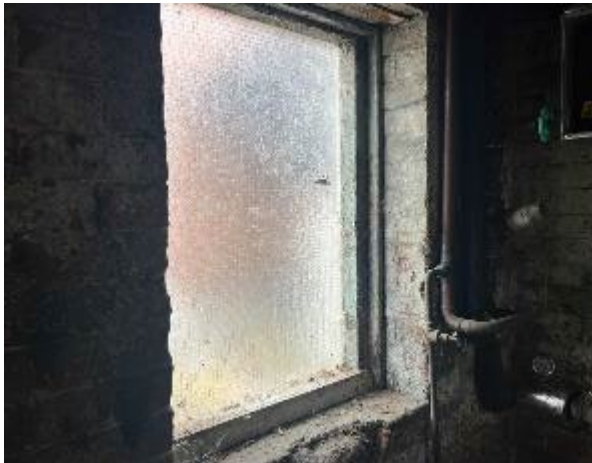
Line ID 55: Internal, Accommodation Building, Boiler House, Timber Windows, Light Blue Paint - Lead Detected (3.3% w/w)

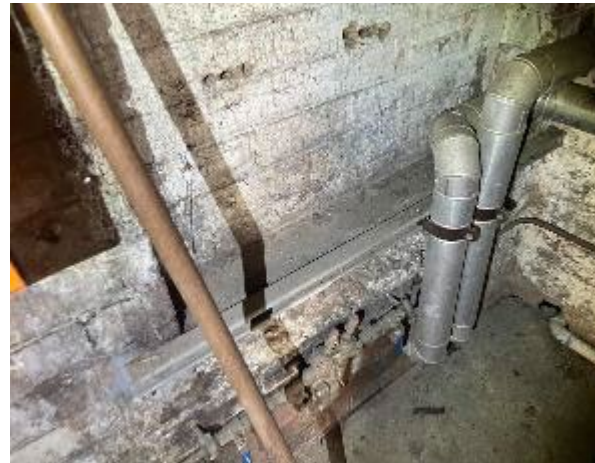
Line ID 56: Internal, Accommodation Building, Boiler House, Walls, White Paint - Lead Detected (0.02% w/w)

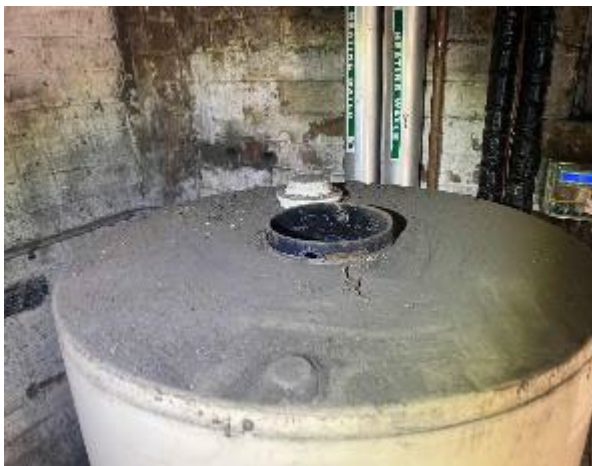
Line ID 59: Internal, Accommodation Building, Boiler House, Throughout Surfaces, Dust - Lead Detected (1,400 mg/kg)

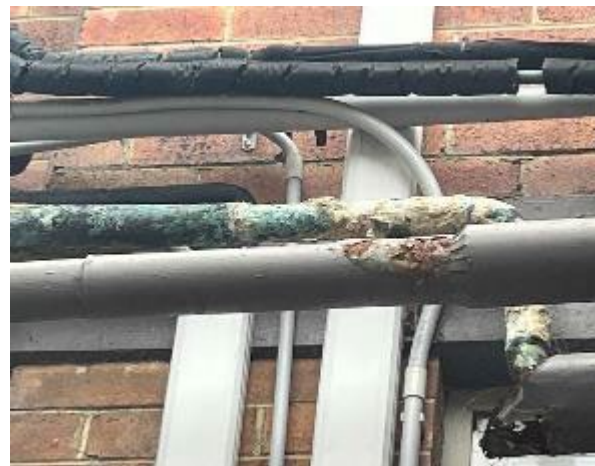
Line ID 60: External, Accommodation Building, Adjacent Boiler House, Pipe Insulation, Insulation Material - Suspected SMF

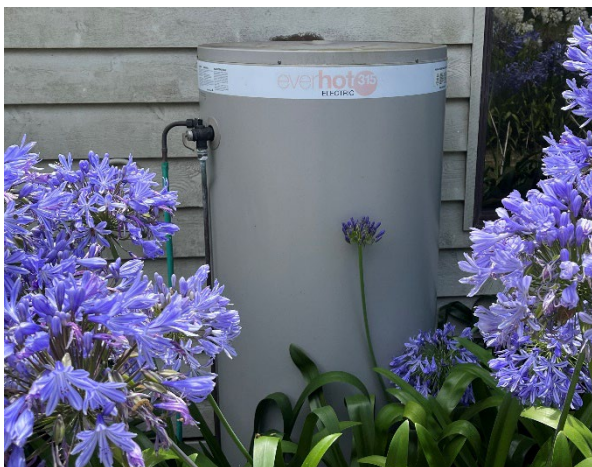
Line ID 61: External, North Residence, Verandas, Hot Water Unit, Insulation Material - Suspected SMF

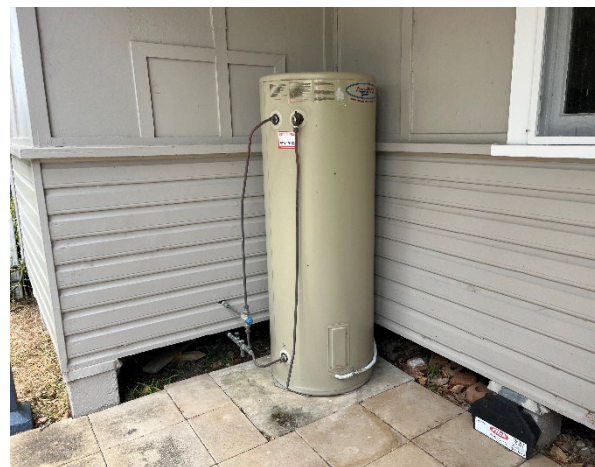
Line ID 62: External, South Residence, Verandas, Hot Water Unit, Insulation Material - Suspected SMF

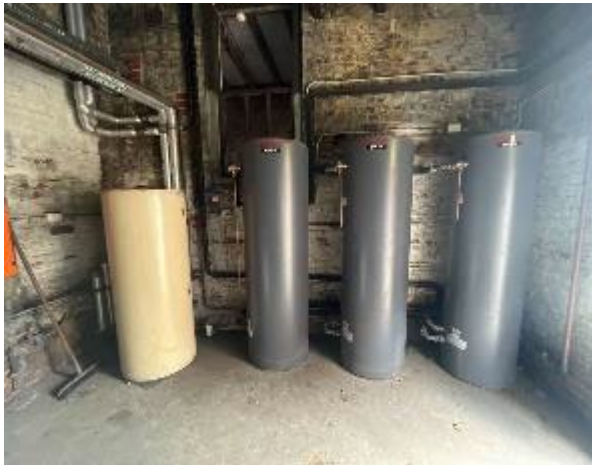
Line ID 63: Internal, Accommodation Building, Boiler House, Hot Water Units, Insulation Material - Suspected SMF

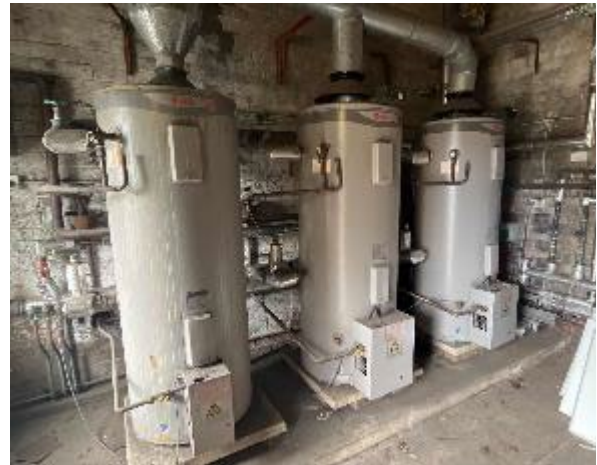
Line ID 63.1: Internal, Accommodation Building, Boiler House, Hot Water Units, Insulation Material - Suspected SMF

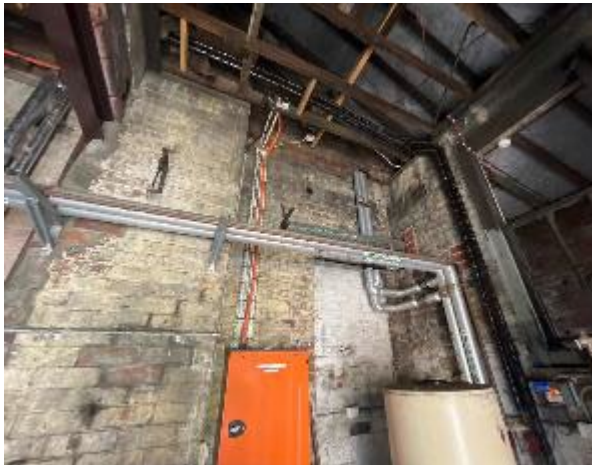
Line ID 64: Internal, Accommodation Building, Boiler House, Pipe Insulation, Insulation Material - Suspected SMF

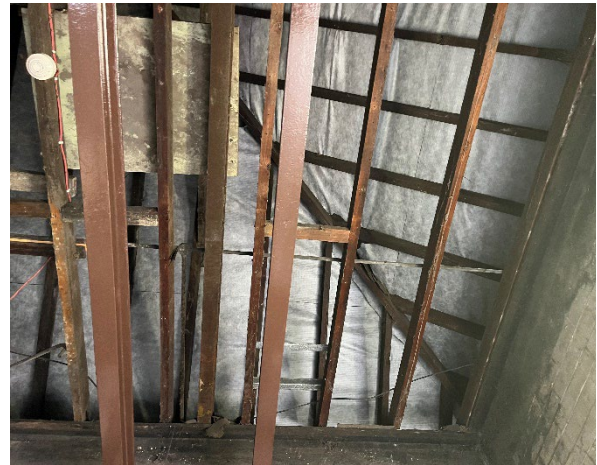
Line ID 65: Internal, Accommodation Building, Boiler House, Underside of Roof, Sarking Insulation - Suspected SMF

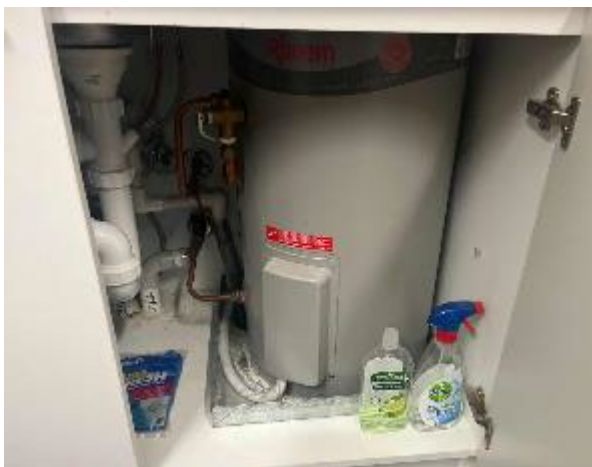
Line ID 66: Internal, Admin Building, Kitchen, Hot Water Unit, Insulation Material - Suspected SMF

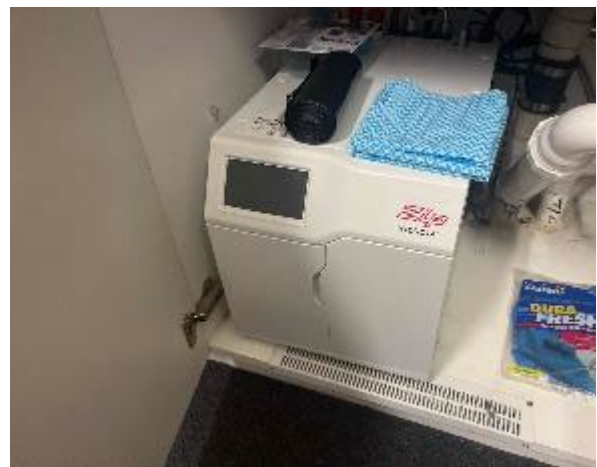
Line ID 66.1: Internal, Admin Building, Kitchen, Hot Water Unit, Insulation Material - Suspected SMF

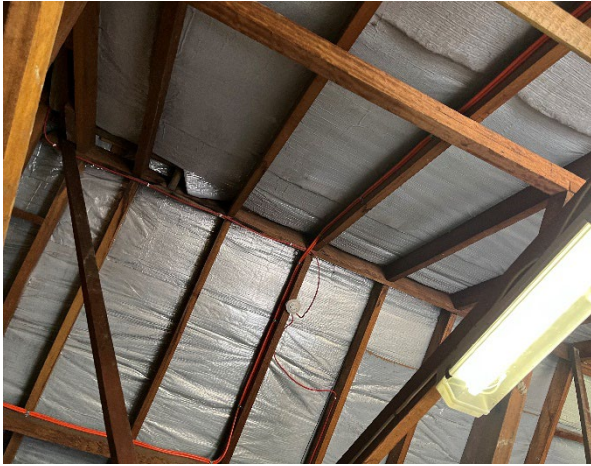
Line ID 67: Internal, Pool House, Throughout,  
Underside of Roof, Sarking Insulation - Suspected SMF
