CONSERVATION AREA MONITORING and BIOMETRIC CONDITION ASSESSMENT

Southern Highlands Regional Shooting Complex
(Hill Top Conservation Area)

OCTOBER 2018

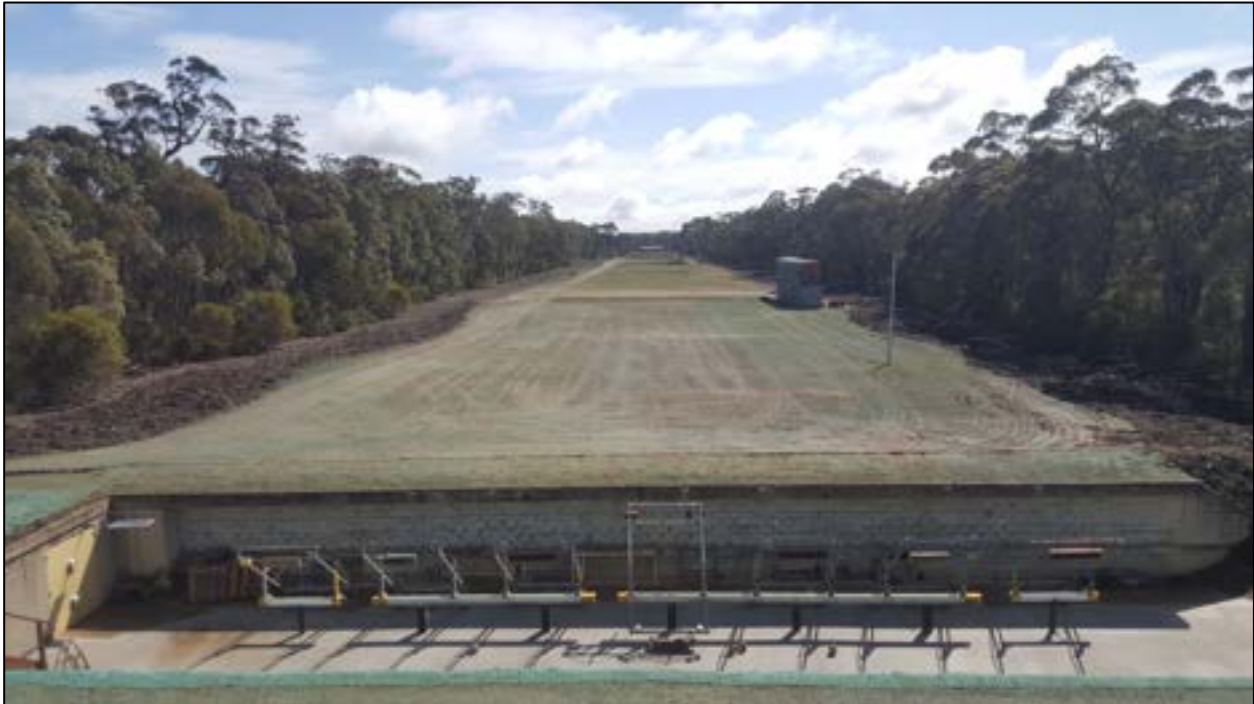
Plate 10a. Looking north-east along existing 800 m rifle range (date taken: 18/10/2018).

Some mulching works have occurred alongside the rifle range.

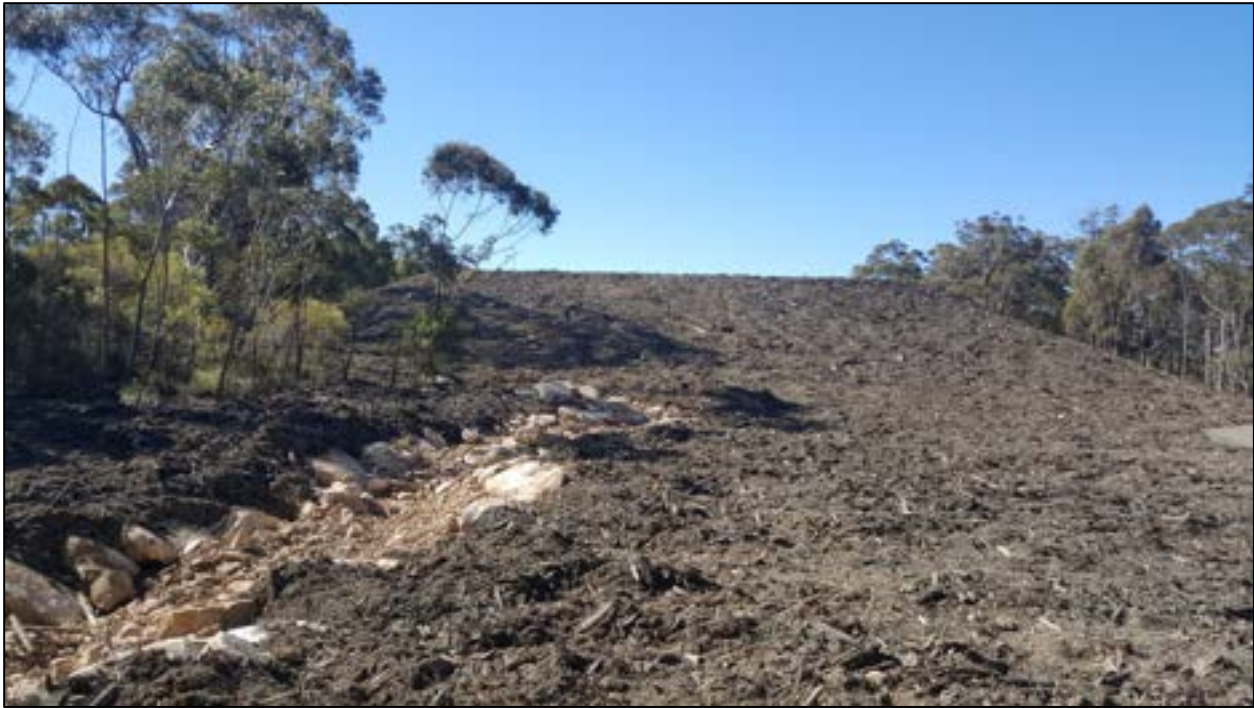
Plate 10b. The disturbed area at the southern end of the 800 m rifle range. Note the attempted rehabilitation measures of mulching and rock placement (date taken: 29/08/18).

Immediately south of this photo-point, the area has recently been contoured to divert and control water and sediment runoff. This has been achieved by placing sandstone boulders and rocks of differing sizes in a drainage formation, and layering mulch around this (Plate 10b). The works have been undertaken as scouring and erosion has occurred, and sediment has been deposited near Plot 1. Deposition of this sediment has resulted in the death of some small trees and shrubs.

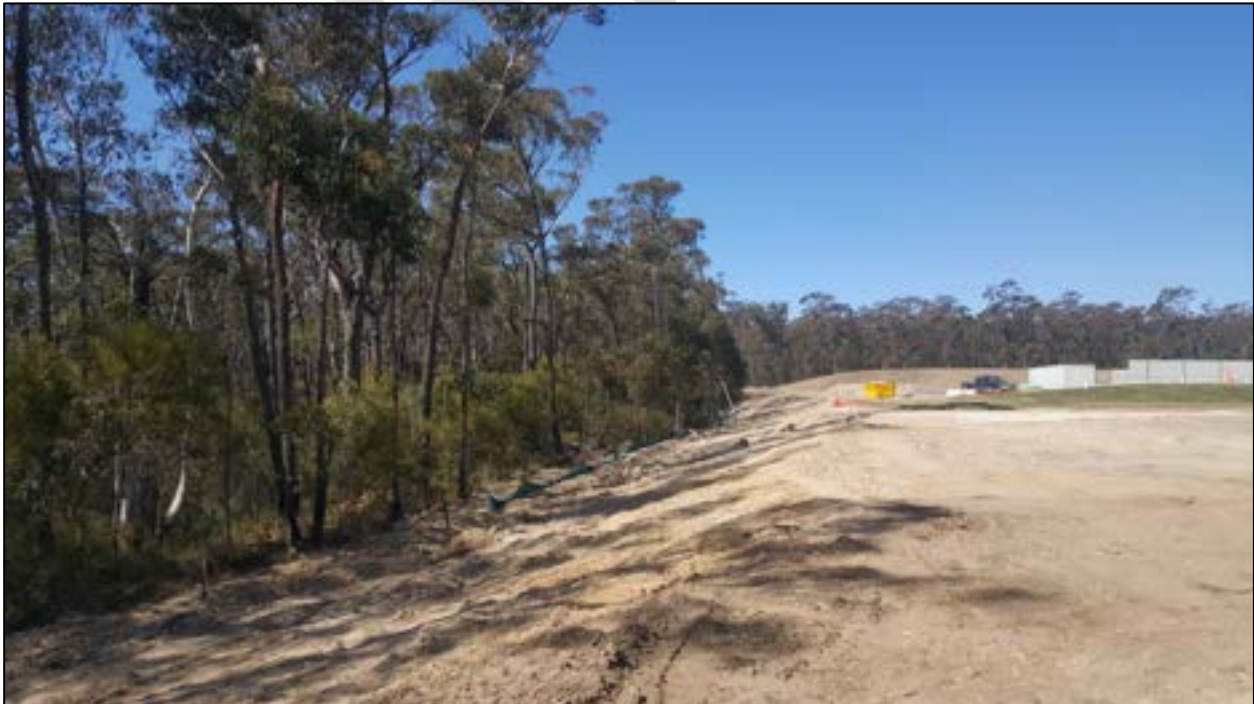
Plate 11. Looking east along the northern boundary of the 50 m gun range under construction (date taken: 29/08/18).

Minor erosion and sediment deposition along the boundary of the 50 m gun range area, adjacent to the woodland, has occurred. Sedimentation fencing has been erected in some areas but requires maintenance (Plate 12).

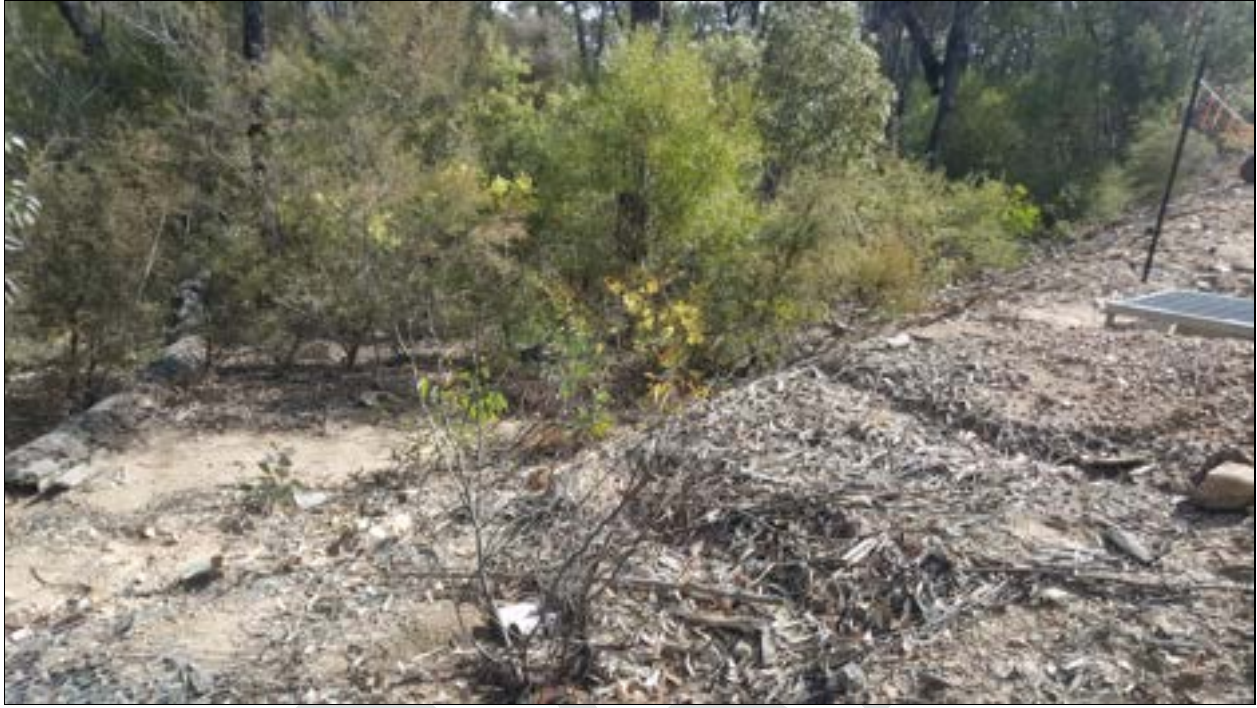
Plate 12. The character of the drainage pit and vegetation at the south-east corner of the 50 m gun range (date taken: 29/08/18).

Sediment deposition is common at the toe of the batter slope and woodland boundary at the south-east corner of the 50 m gun range area (Plate 13) and along the entire eastern batter.

Sedimentation and erosion control must be implemented.

Additionally, rehabilitation of the batter slopes with native grasses and shrubs is proposed to be undertaken.
